CHARACTERISTICS OF SLOP FAILURES AND LANDSLIDE DAMS CAUSED BY THE 2008 IWATE-MIYAGI NAIRIKU EARTHQUAKE

Yoshiharu Ishikawa¹ and Takayuki Ishikawa²

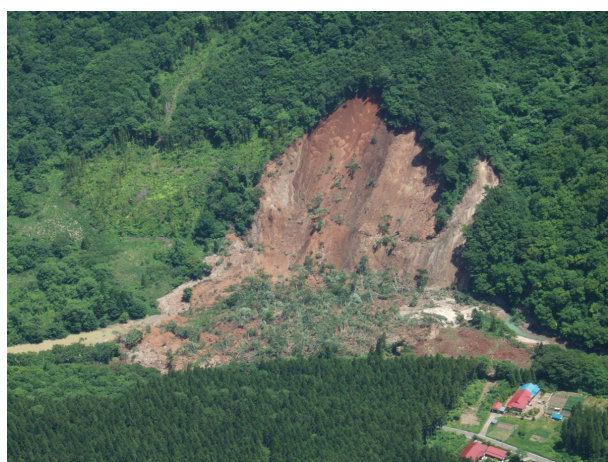
Fig.3 Slope failure and landslide dam at Ogawara, Ichihasama River

This earthquake created many landslide dams (Fig.3, 4) owing to the fact that many slope failures occurred near the rivers (valleys), as shown in Fig.14 and Fig.15. The surveyed basins were generated after the rivers dissected pyroclastic materials and other thick sedimentary layers. Therefore, the slopes on the riverbanks have a high degree of incline and large elevation differences, resulting in many slope failures occurring on the banks and subsequently many landslide dams. Many slope failures occurred in the third to fifth order valleys, as shown in Fig.16 and Fig. 17. Most failed slopes that formed the main landslide dams are at a distance of approximately 250 m from the center of the river course, as shown in Fig. 18. It is estimated that landslide dams are easily formed in areas where the riverbank slope has a large elevation difference (large distance) and the riverbed has a relatively gentle inclination (third to fifth order valleys).

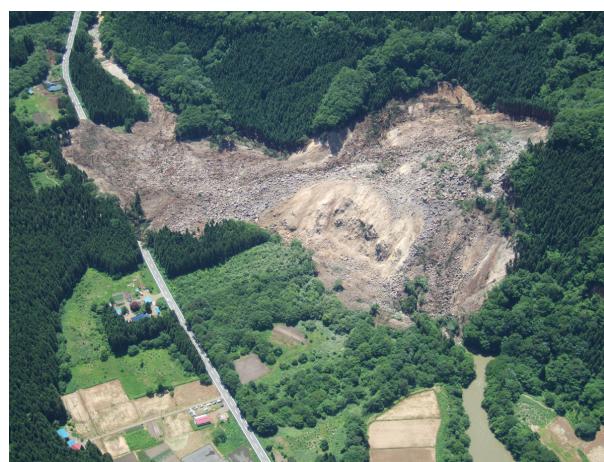
Fig.4 Slope failure and landslide dam at Azabu, Ichihasama River

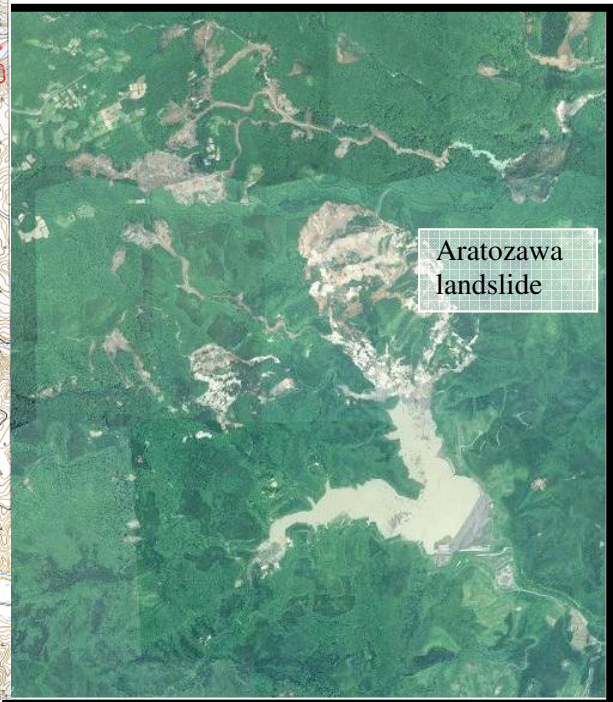
Fig.6 Aerial photograph after the earthquake taken by Asia Air Survey Co. Ltd

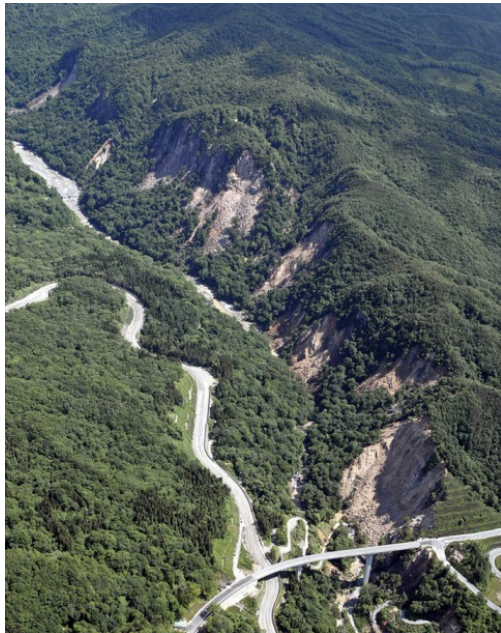
Fig. 14 Slope failures along Ichihisama River
