ANALYSIS OF TORRENT PROTECTIVE STRUCTURES AS A BASIC ELEMENT OF THE HAZARD MAPPING PROCESS

DETERMINING THE AS-IS-STATE OF 100 YEARS OLD CHECK DAMS MADE OF NATURAL STONE MASONRY

Bernd Kister¹, Markus Zimmermann², Gabi Hunziker³, Bruno Zimmerli⁴ and Walter Fellmann⁵

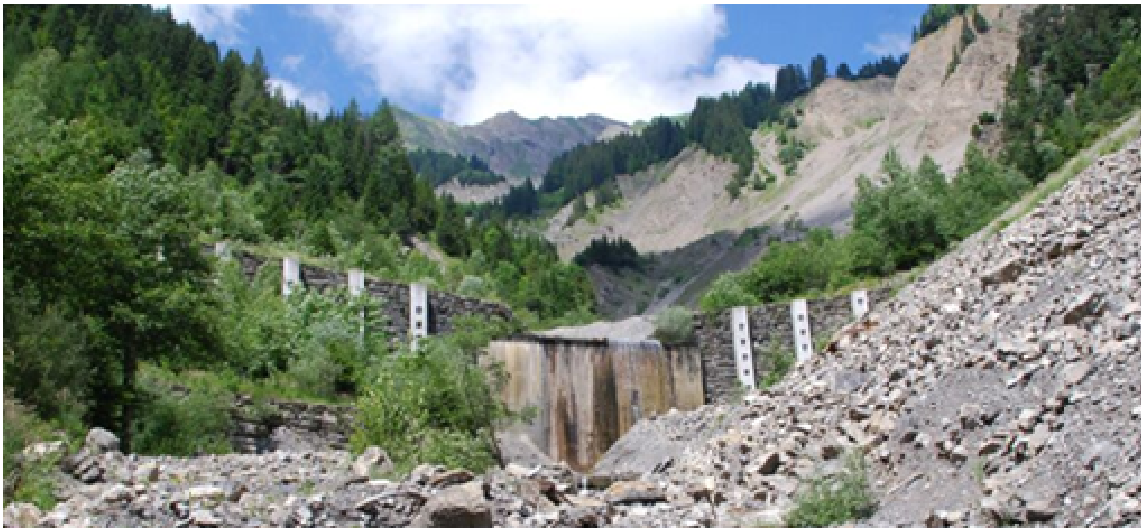
Fig. 5 Check dam IVa with rehabilitation measures, middle part fixed by a concrete plate and pre-stressed anchors in 1976, buttresses and pre-stressed anchors installed at the barrier wings in 2000

Check dams III and IVa are examples for an increasing load at the upstream side of the barriers due to aggradation. The results of the photogrammetric survey in the Lammbach gorge show for example the steady rise of material behind check dam IVa within a period of the last 65 years. Additional on both check dams changes had been done at the supporting structure in the context of rehabilitation measures. Because of the complexity in geometry, load cases and material behavior of those 2 large check dams III and IVa, 3D-Finite-Element calculations had been chosen for the analysis of the structural safety. Fig. 13a shows the 3D-FE-mesh of check dam IVa used for the calculations. It consists of 25'160 3D-elements, 49 discrete anchor elements and 1'393 interface elements. The calculations have been done using linear elastic and elastic-plastic material behavior for the check dam. Mohr-Coulomb failure criterion and a tension-cut-off model as well as the multi-laminate model have been used to simulate the masonry. For the subsoil and the securing mean (concrete slab, buttresses and anchors) elastic behavior has been chosen.

The calculations for check dam IVa show a deformation which was less than 10 cm in maximum. The anchor load show a value which is nearby, but lower than the tolerable value. Therefore even if the water level rises up to the level of the spillway and a debris flow occur additionally the calculations show no failure of check dam IVa.

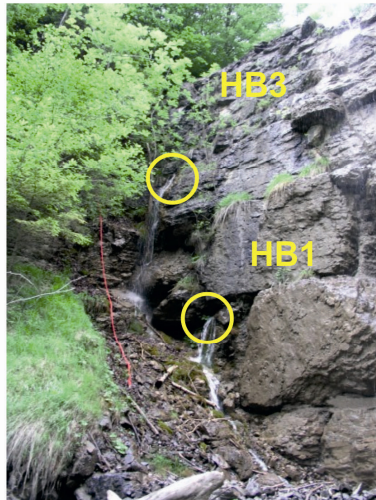
Rating	BW	HB 1	HB 2	HB 3
structure :	q_{Mk}	0.47			
slenderness ratio	RKB	0.9			
anchoring depth	RKF	0.9			
constructiveness	RKG		0.58	0.61	0.64
as-is state structure :	q_{Mz}	0.5			
structure as a whole	RZN	1.0			
settlement	RZS	1.0			
bond	RZV	1.0			
discharge section	RZA	1.0			
drains / water	RZE	0.5			
as-is state elements :	q_{Bs_z}	0.89			
rock blocs + mortar	RZM		0.89	0.89	0.89
surrounding area :	q_{TG_z}	0.42			
plant cover	RZB	0.85			
subsoil	RZU	0.5

Fig. 7 Example for the rating system: missing information about the transverse bracing and large variation in bloc size of check dam I induced a low value for rating RKG, check dam I shows significant water outlets at the western part (circles), this results in a low value for the rating RZE (drains / water), indication for an undercutting of the check dam led to a reduction of the rating RZU, BW: structure, HB: homogeneous segment

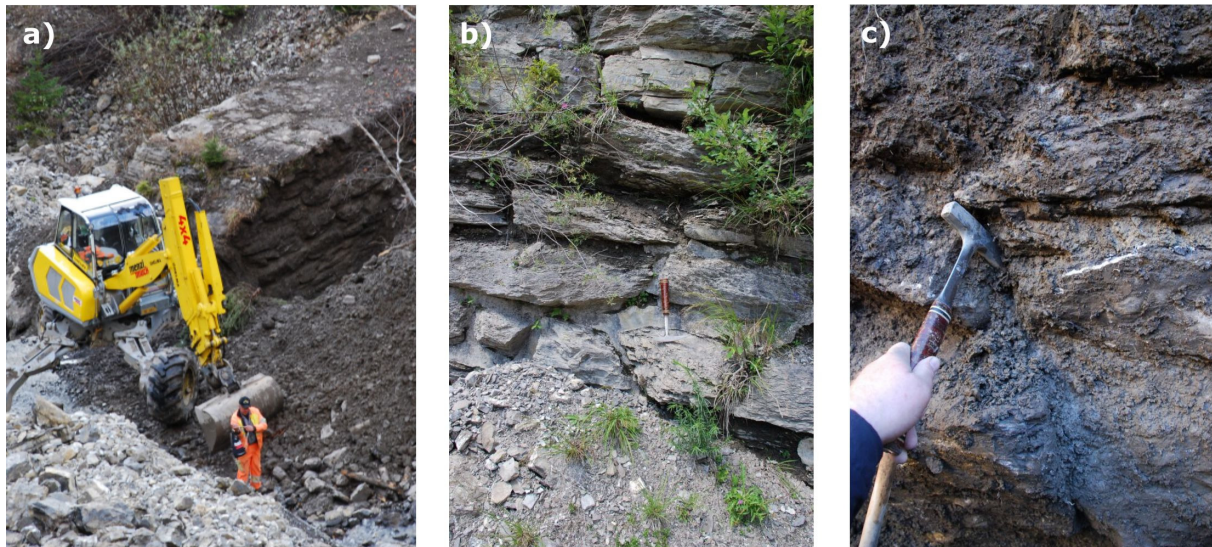
The status of the masonry at the upstream dam face was found better than that one at the downstream face (Fig. 8, b and c). The decomposition of mortar in the masonry joints on the upstream face was predominantly less than 10 cm. At the same check dam the decomposition of mortar in joints at the downstream face often shows a greater depth, the maximum found at check dam IVa was 50 cm. The excavation of the trial pits eliminated also some lack of clarity concerning the thickness of the construction and the shape of the cross section.

During the drilling work water outlet at the masonry downstream side was detected approximately 1 m before the drilling bit reached the structure surface. Therefore it can be stated, that the depth of weathering of the masonry is approximately 1 m.

The mortar found in the drillings can be described as a tamped concrete with coarse grained aggregates and large porosity. This “mortar” is very much different from that found at the structure surfaces. Two specimen for uniaxial compressive strength tests were obtained with the drillings. The test result of the sample of check dam IVa was $\sigma_{d,R} = 6 \text{ MN/m}^2$, the test result of the sample of check dam IV was $\sigma_{d,R} = 15 \text{ MN/m}^2$. In both cases the uniaxial compressive strength was very much smaller than the values determined with the Schmidt-hammer on mortar at the check dam surfaces

Fig. 8 Check dam IV: a) trial pit at the upstream side, b) joints and decomposition of mortar at the downstream face, c) joints and decomposition of mortar at the upstream face.

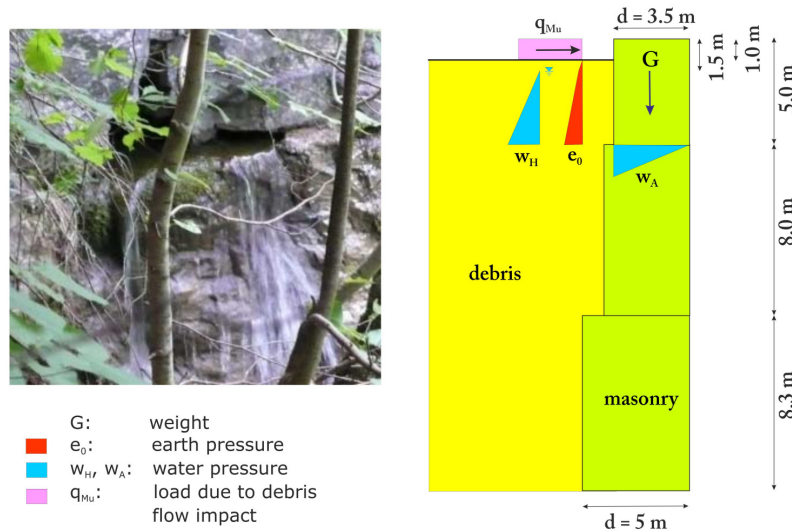
In the second step the potential failure mechanisms and hazard scenarios had to be detected and the forces acting on the constructions had to be determined. For example at check dam I a water outlet has been detected at the interstice between the former spillway and the part which has been erected at a later date. The erected part has a length of about 23 m and the fixed support at the side may be incomplete. In case of large debris flows with latitude larger than the today spillway dimensions a debris flow impact may occur and this part of the construction may fail by toppling. A 2D-approach in this case is sufficient to describe the problem. Fig. 10 shows the cross section as well as the loads acting on the upper part of the check dam.

Fig. 10 water outlet and cross section of check dam I, position of the water outlet at 5 m below the capstone

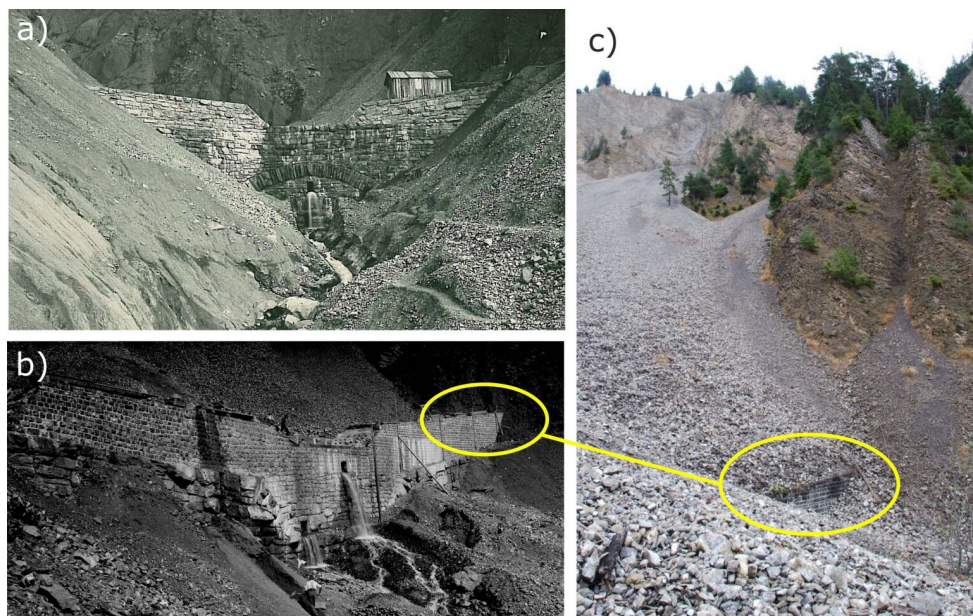
The 3rd step deals with the estimation of the functional capability of the adopted measure. The structural safety as well as the fitness for purpose of the structures has to be checked. An example for loss of effectiveness due to aggradation is check dam V. Today this barrier is covered by debris except for a very small part at the eastern barrier wing (Fig. 12c). At the spillway the thickness of the debris layer today is several meters. Therefore check dam V has lost its fitness for purpose according to the primary design (cp. Fig. 2). But even in this status the check dam is of high importance for the complete torrent control system because in case of a large debris flow it limits the erosion of material to the level of the barrier's crown.

Fig. 12 Changes at check dam V: a) when finished in 1904, b) increased in height in 1936, c) the only visible part of check dam V today (OIK).

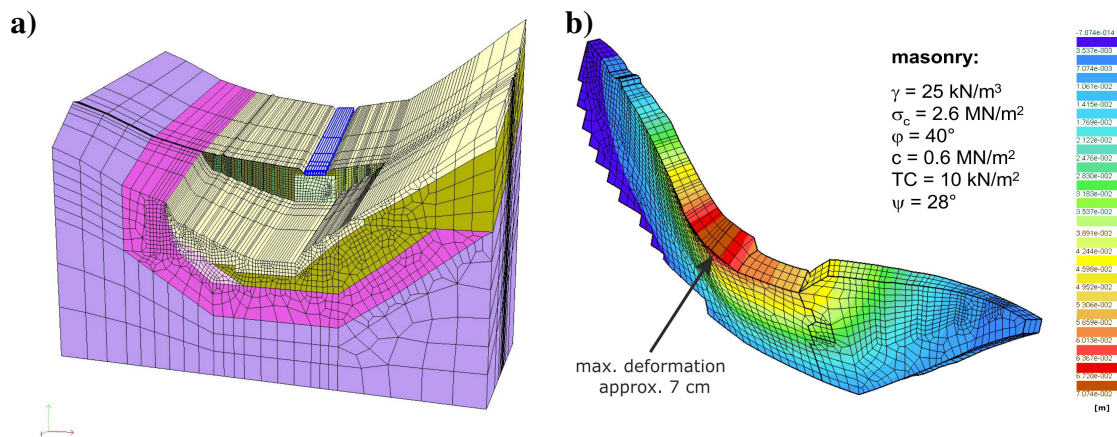
Fig. 13 a) 3D-FE-mesh of check dam IVa and the subsoil, b) deformed mesh of check dam IVa for a calculation with a tension cut-off model $\tau_{TC} = 10 \text{ kN/m}^2$, shown is the last load case: overtopping by debris flow.
