Assessment of Landslide Recurrence by Onsite Monitoring - Incidence of Hong-yeh Landslide -

Key words: landslide, recurrence assessment, onsite monitoring, numerical simulation

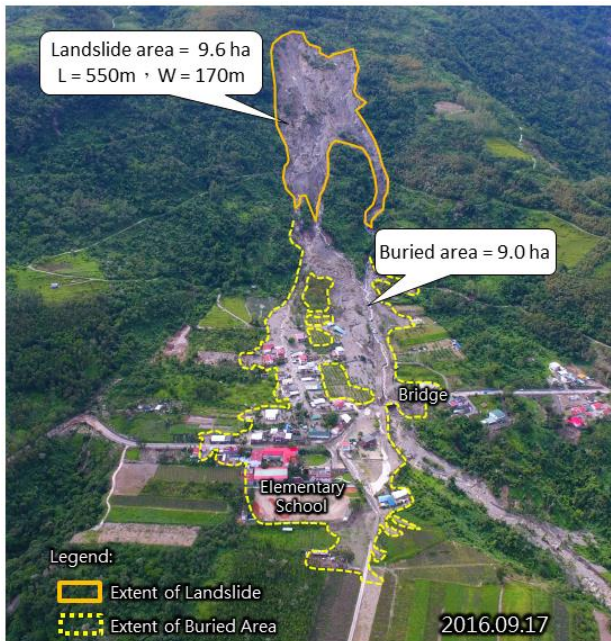
Typhoon Meranti invaded Taiwan from Sept. 12 through Sept. 16, 2016 and brought 633 mm of rain in 48 hours. A large-scale landslide occurred behind Hong-Yeh Village in Taitung County on Sept. 15, with an extent covering 7.8 ha from which 40,000 m³ of debris were yielded. The front lobe of debris rushing downstream damaged 39 housings, three public buildings as well as local traffic system that situated at the foothill of the mountain range (**Fig. 1**).

Fig. 1 Disaster caused by September 15, 2016 landslide

Check dam and gully control structures were immediately designed and commissioned for construction. Debris that affecting local settlement was removed, and that blocking the clearance of bridge and torrent was dredged. Locations for permanent resettlement were evaluated.

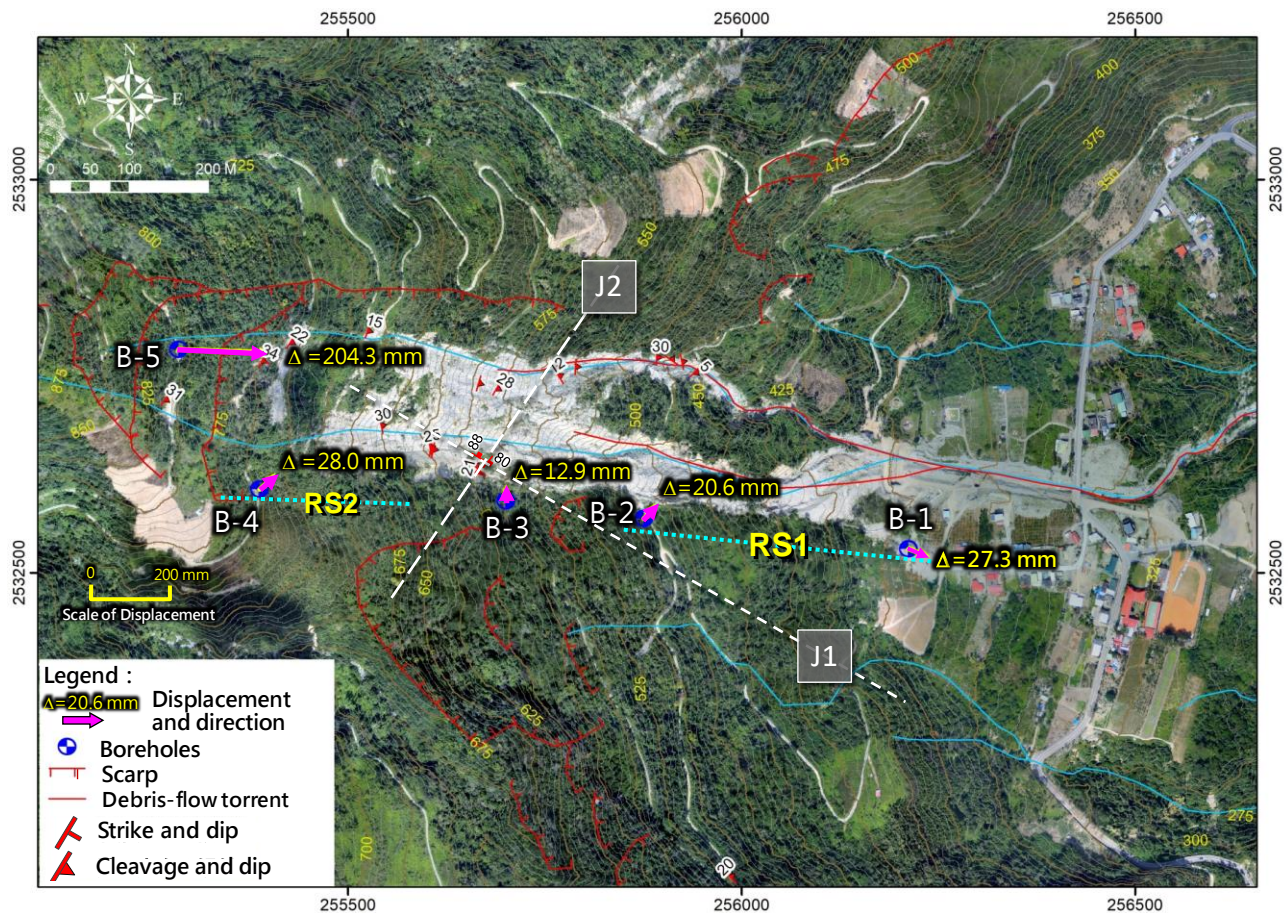
Field survey also found the representative weak planes formed by J1 and J2 joint (Fig. 2) respectively that affecting hillslope stability. J1 joint is less

apparent and discontinuous; whereas, J2 joint forms the major joint with good ductility that fractures the rock stratum for more than 1 m and quartz veins [Yang, 2010] was found along tension joint fissures. Evidence collected onsite suggested that J2 joint was the weak plane that mainly affected the hillslope stability and caused landslide to occur.

Fig. 2 Results of field geological survey and total displacement readings from each borehole

The monthly average displacement rate taken from borehole B-1 to B-4 was 5.5, 4.1, 2.6, and 5.6 mm/mo. respectively; whereas the monthly average displacement rate from B-5 reached 40.9 mm/mo., which met the confirmed mass movement criterion proposed by Japan Association for Slope Disaster Management [2007].

shown in **Fig. 9**. One of the possible reasons that causing no response of water level in B-5 on July 4 event was the sliding of active moving stratum (**Fig. 6**) that rearranged the stratum structure, porosity, and permeability. The entire hillslope at the vicinity of B-5 moved 50 ~ 100 mm between May 22 and June 26 and continued its movement with approximately the same speed that led to a total displacement of 204.3 mm at B-5 as that shown in **Fig. 2**.

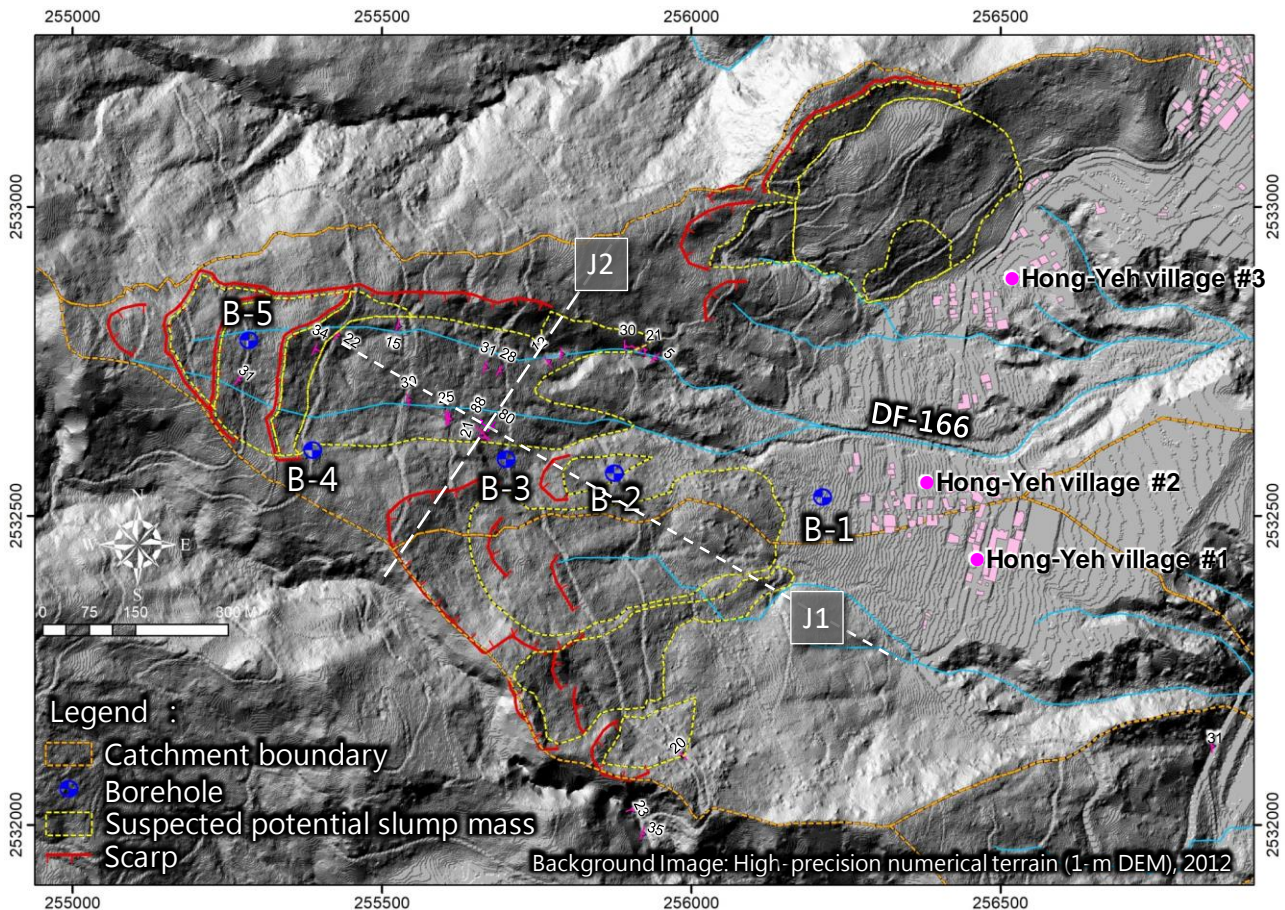
Micro-terrain interpretation was conducted by analyzing satellite images and orthophotos taken from various periods. Interpretation results suggested that hillslope behind Hong-Yeh Village not only possesses avalanche features but also experienced large-scale landslide during modern geological history. Fig. 3 is the results obtained from micro-terrain interpretation, in which boundaries of suspected potential slump mass and that of landslide scarps were marked.

Fig. 3 Results of micro-terrain interpretation

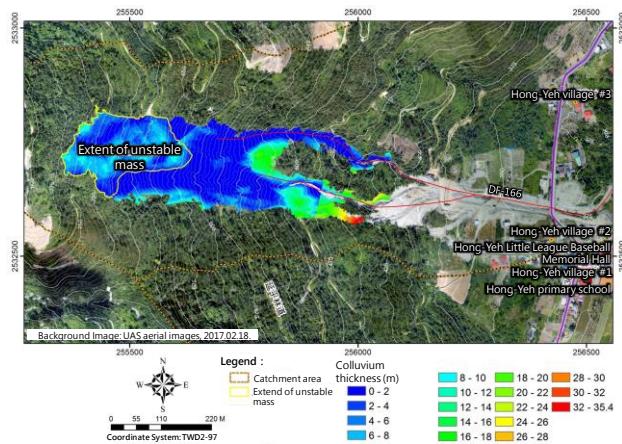
By examining the depths of colluvial deposits from five boreholes' core samples and the field findings from fresh outcrop survey, we were able to estimate the thickness of colluvial deposits as that shown in Fig. 4.

Estimation of colluvial deposits especially the extent of unstable mass as that shown in Fig. 4 helped corresponding government agencies as well as residents of Hong-Yeh Village prepare for the worst scenario to come. It also helped emergency relief task forces to seek all control practices options and landslide recovery actions.

Fig. 4 Estimated thickness of colluvial deposits

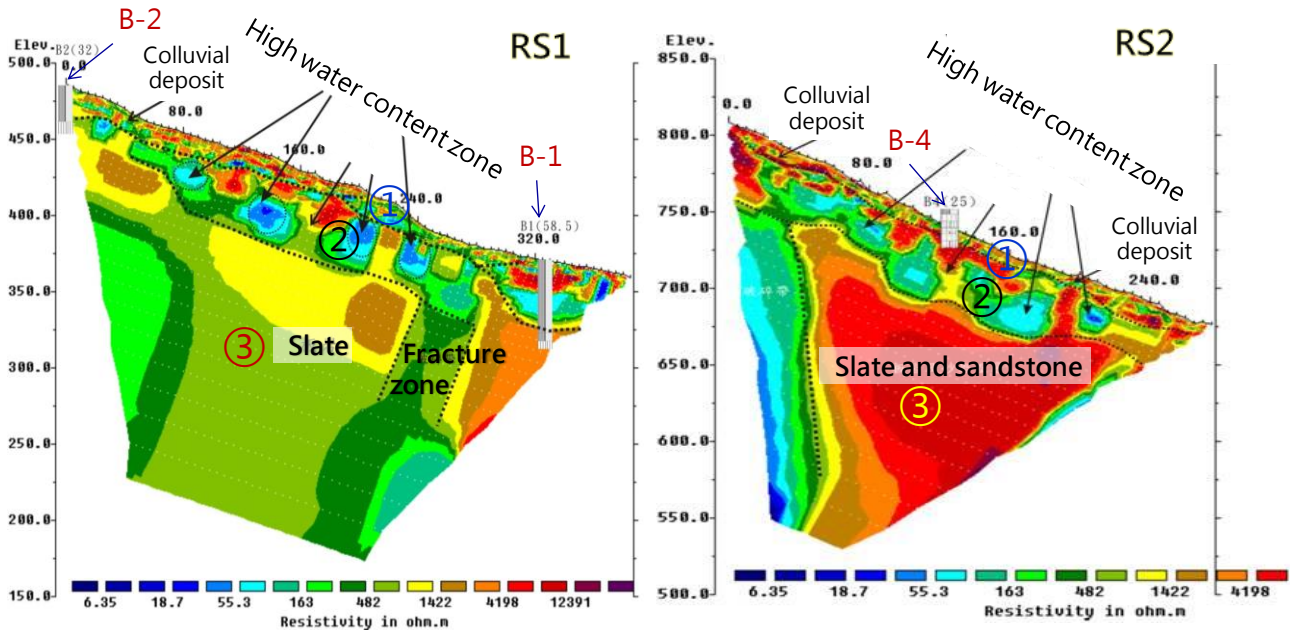
Electrical resistivity distribution readings taken along Route 1 (RS1) and Route 2 (RS2) suggested that rock stratum at the landslide site consists of three main layers. They are colluvial deposits, fracture zone, slate, and/or slate and sandstone interbed, where are denoted as ①, ②, and ③ respectively in Fig. 5.

Joints are abundant in the fracture zone so that surface water can easily seep into and form water pockets that were clearly registered in electrical resistivity readings as that shown in Fig. 5. This fracture zone may affect the stability of hillslope and the maximum affecting depth may reach 50 m.

Fig. 5 Electric resistivity readings from Route 1 (RS1) and Route 2 (RS2)

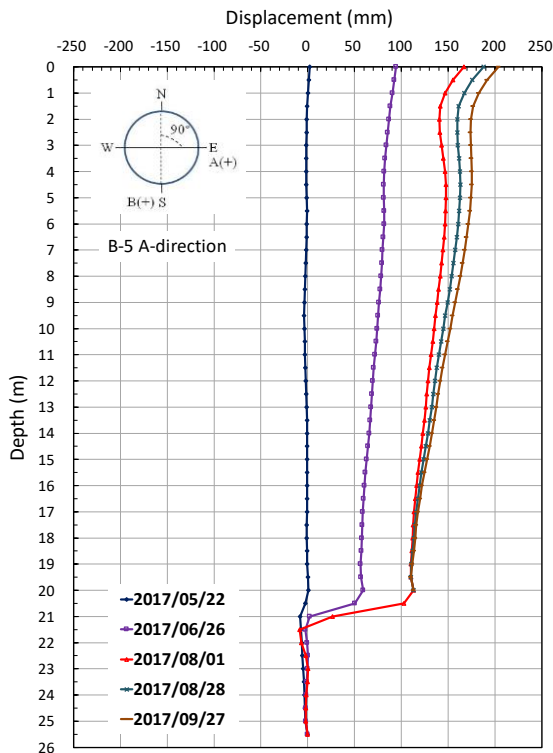
The active moving zone in B-5 that estimated from inclination readings in the A-axis direction (pointing downslope) was about 21.0 ~ 21.5 m underneath the ground surface as that shown in **Fig. 6**. Inclination readings from B-5 also indicated that landslide is continuously moving in a rapid speed. All these evidences clearly verify the existence of dip slope.

Fig. 6 Inclination readings from borehole B-5

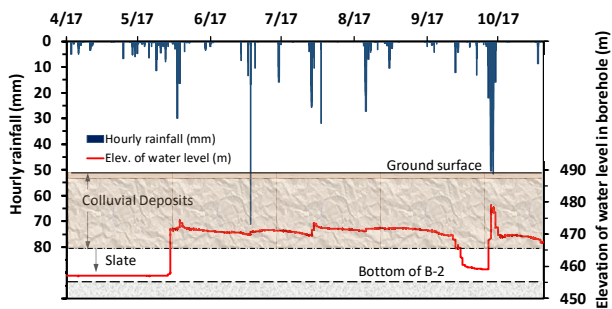
In general, water levels in borehole were found synchronized with rainfall for B-2, B-3, and B-5 that situated along the landslide scarp. In contrast, there were almost no apparent changes in water levels for B-1 and B-4.

Fig. 7 Records of elevation of water level from borehole B-2

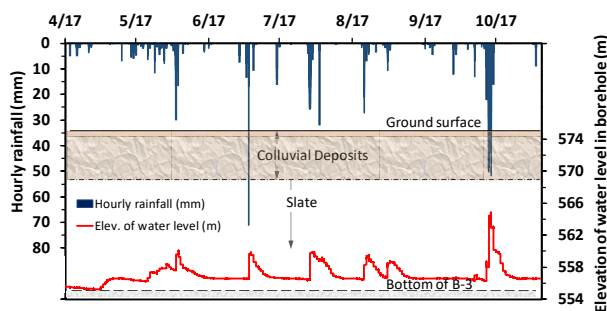
Fig. 8 Records of elevation of water level from borehole B-3

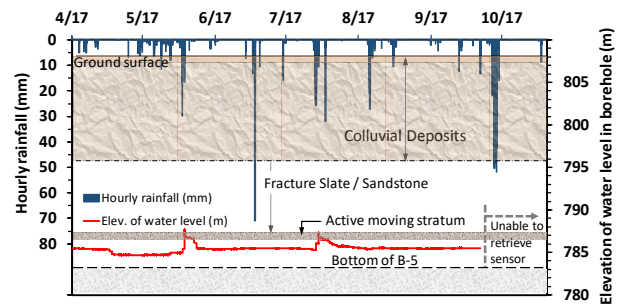
Three rainfall events occurred on June 3, July 4, and July 30 which brought 117.5, 91.5, and 204.5 mm of rain with the maximum hourly intensity of 16.5, 71.0, and 29.0 mm/hr to the site respectively. The water level in B-5 rose on June 3 and July 30 events to the elevation where suspected active moving stratum was located, but not on July 4 event as that

Fig. 9 Records of elevation of water level from borehole B-5

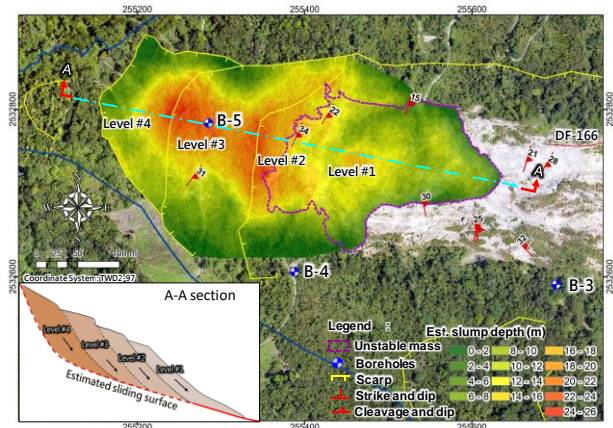
Judged by results from field geological survey, landslide scarp, micro-terrain interpretation, stratum distributions from core samples as well as inclinations and water level readings in boreholes, we reached the conclusion that recurrence of landslide is very likely. We speculate future landslide will probably occur in four levels as illustrated in **Fig. 10**.

The total unstable mass counting all four levels was estimated to reach 920,000 m³.

Fig. 10 Recurrence of possible sliding in levels

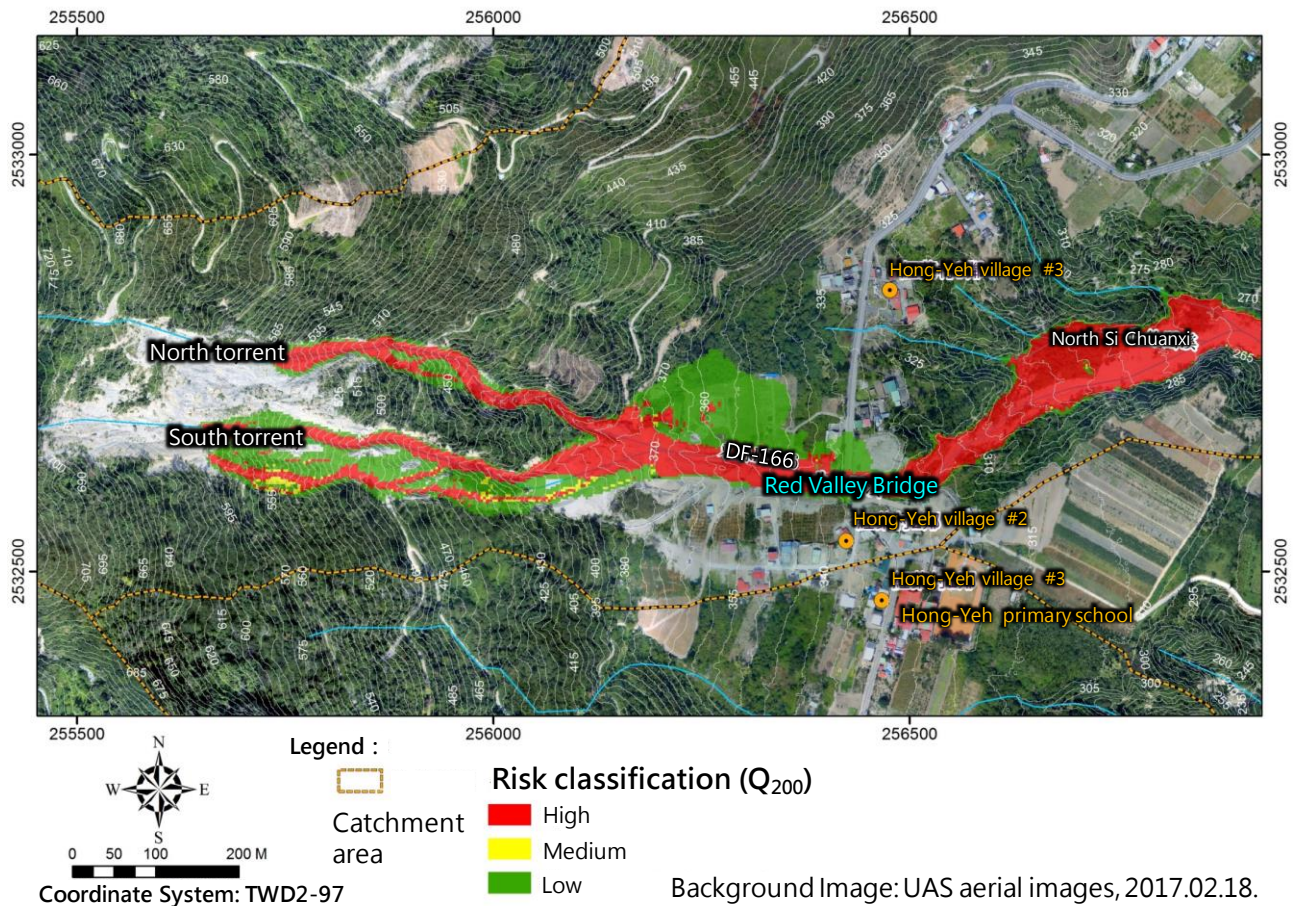
Fig. 11 Extent of debris-flow risk from 200-yr return period event if occurred during the construction of countermeasures

Simulation results shown in **Fig. 11** indicated that there was a weak spot along the left embankment after the confluence where North and South torrents met, at which 200-yr return period debris flow may overflow. Another possible overflow spot was likely to occur before Red-Valley Bridge because the clearance under Red-Valley Bridge was insufficient to convey the flood.

Scenario III simulation was carried out by altering the elevations at left embankment, clearance under Red-Valley Bridge, and channel cross section after Red-Valley Bridge. Runoff from 200-yr return period was also used as inflow.

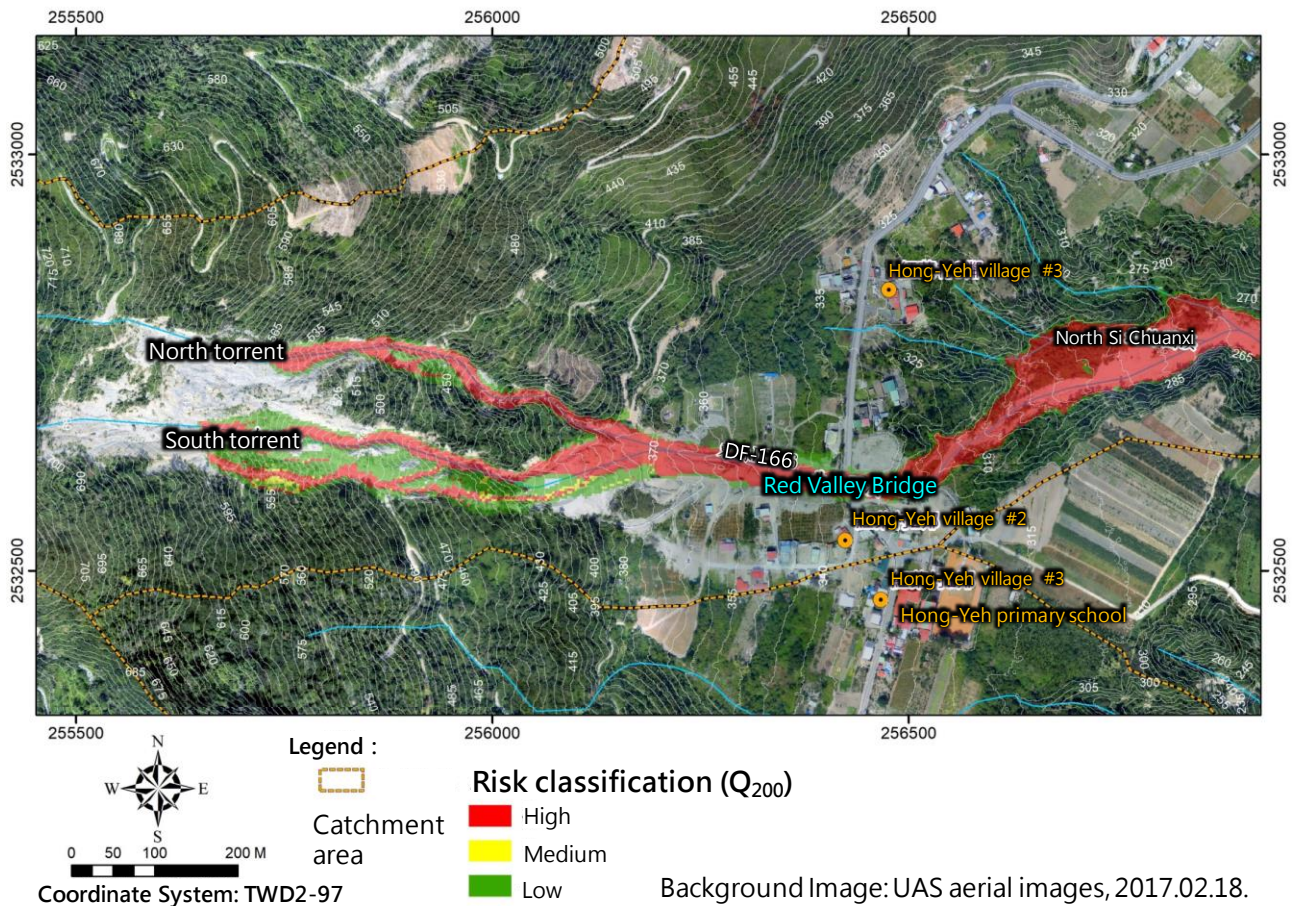
Fig. 12 illustrated the simulation results using the topographic map obtained from field topographic survey conducted on June 19, 2017, which

Fig. 12 Extent of debris-flow risk from 200-yr return period event if occurred after the construction of countermeasures

represented the completion of gully controls with necessary adjustments at spots where overflow or debris clogging may likely occur. Adjustment involved in gully control designs included increasing left embankment height by 2.5 ~ 3.0 m, increasing Red-Valley Bridge clearance to 7.0 m, and expanding channel width to 22.0 m. Results summarized in **Table 1** showed that 40.1% reduction in risk extent from 37,463 m² of Scenario I to 22,445 m² of Scenario III.
