# Emergency Responses to Debris Flow Disaster at Serizawa District, Nikko City Triggered by the 2015 Torrential Rains in the Kanto and Tohoku Region

Kenji MIWA<sup>1</sup> and Kenji TAKETOSHI<sup>1</sup>

<sup>1</sup>Member, Nikko Sabo Office, Kanto Regional Development Bureau, Ministry of Land, Infrastructure, Transport and Tourism (2390 Hangakimen, Nikko City, Tochigi 3211414, Japan)

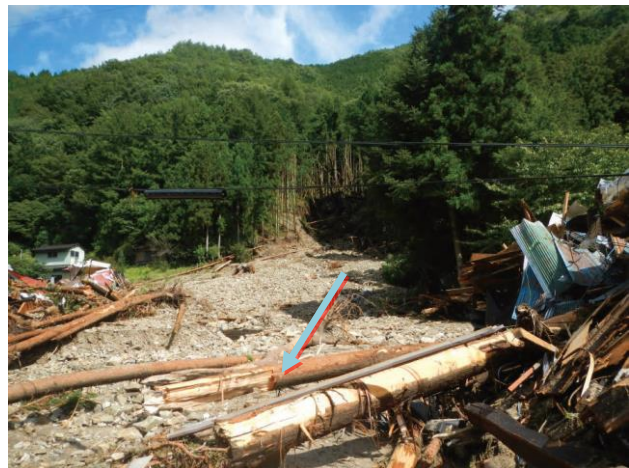
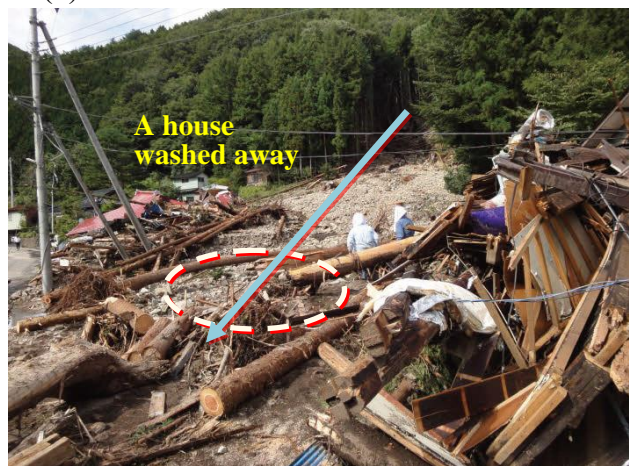
In Takimukaisawa, two people were injured and their houses were washed away. Debris flows completely or partially destroyed many houses. Luckily there were no deaths. Later we interviewed the inhabitants. “The house tilted after being hit by a debris flow. I was shocked and jumped out of the house.” “A fallen beam fell onto the bed board where it stopped, which created a space and saved me.” “I was covered in mud up to my waist. Somehow I managed to crawl out by following the directions of my neighbors. This is how I survived.” These are some of the stories from the inhabitants whose houses were completely destroyed. Considering these stories, it was clearly miraculous that there were no deaths.

Fig. 6 Damage in Takimukaisawa, Serizawa District  
(a) Sediment and driftwood run off  
(b) A damaged house (two people injured and three houses completely destroyed)

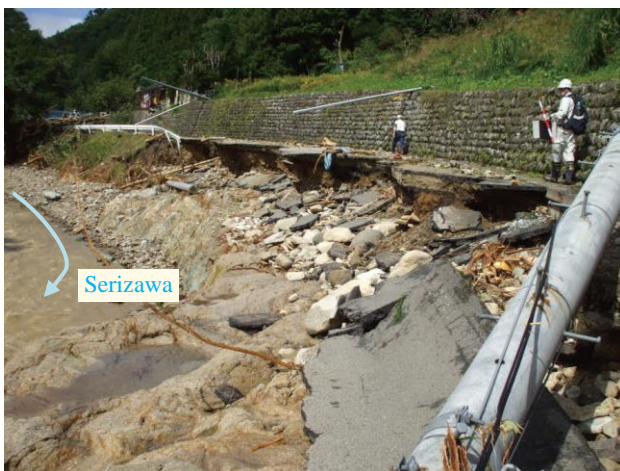
Sediment runoff from the mountain streams cut off traffic on the municipal road. River bed aggradation and swelling of the main river of Serizawa eroded river banks and partly washed away the municipal road (Fig. 7). Lifeline utilities installed along the municipal road, such as electric, telephone (land line and mobile), water and communication lines were also severed and 25 inhabitants in 14 households were temporarily isolated in an upstream village [Uenaka, 2016; Nikko City, Tochigi prefecture, 2016].

Fig. 7 Municipal road washed

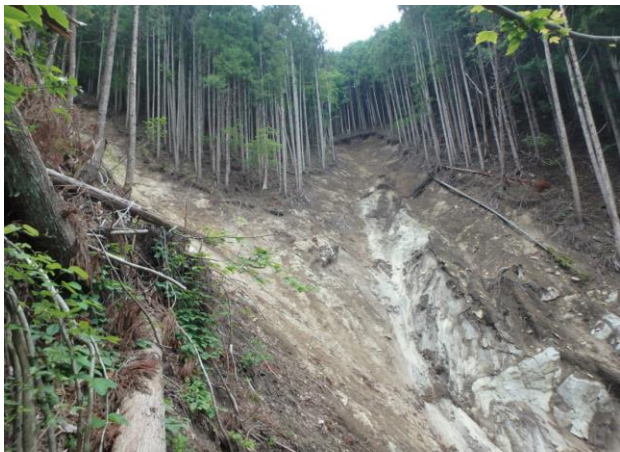
Traces of sediment production phenomena such as slope failures, longitudinal erosions, gully erosions and bank collapses were recognizable in the mountain streams. These phenomena occurred from torrential rains and the resultant swelling of the water. The swollen water may have combined with the sediment before turning into a debris flow (Fig. 8).

Headwaters in Shimotsubouesawa  
Fig. 8 Sediment production

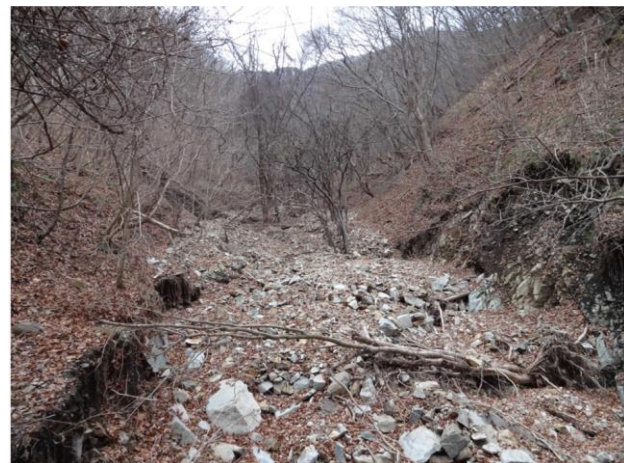
Each of the seven mountain streams from which the debris flow occurred lacked gigantic stones and the accumulation of many substances such as fine grains and breccia with particle sizes ranging between 10 and 40 centimeters were identified. A large quantity of driftwood washed away and accumulated in all of the affected areas excluding Shimotsubosawa. Because there was no evidence of deep erosion like exposed bedrock, with the exception of the upper part, we inferred that sediment movement mainly took the form of sediment flow (Fig. 9) [Sakurai, 2015; Kanto subgroup of the Japan Society of Civil Engineers/Japanese Geotechnical Society collaborative group for investigation of the 2015 Kanto and Tohoku torrential rain disaster, 2016; Sabo Department, National Institute for Land and Infrastructure Management and Erosion and Sediment Control Research Group, Public Works Research Institute, 2015].

Shimotsubosawa  
Fig. 9 Sediment runoff

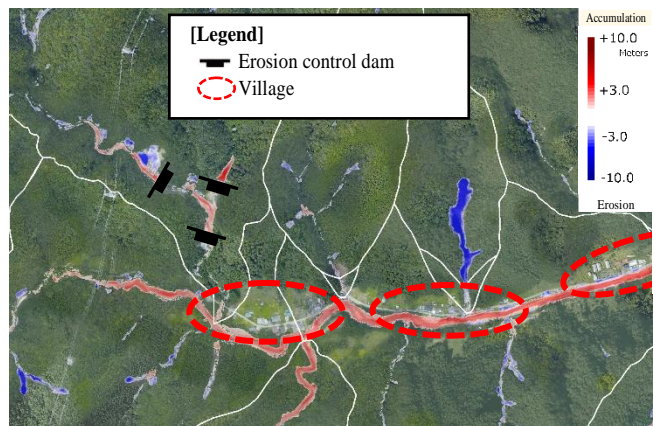
Fig. 10 Aerial difference analysis result

**Fig. 10** shows the result of an analysis of the difference between the aerial laser survey measurements obtained in the Serizawa District Basin in 2012 and those obtained right after last year's disaster. The degree of damage is classified according to shades of colors, with accumulations indicated in red and erosions in blue. Upstream areas of the mountain streams, characterized by their steep slopes, underwent sediment runoff due to slope failures and bank erosions, while sediment accumulation is obvious in the downstream areas of the mountain streams, characterized by mild slopes, as well as the main river of Serizawa and the erosion control facilities. Sediment accumulation was remarkable in the main river of Serizawa, where the river bed rose locally three to four meters at its maximum.

Concerning the sediment balance, erosions and accumulations amounted to nearly 876 thousand cubic meters and 689 thousand cubic meters, respectively in the Serizawa District Basin overall (the sediment amount controlled by the eight existing erosion control dams was approximately 140 thousand cubic meters). We inferred that nearly 187 thousand cubic meters of sediment might have entered the Ojika River. Considering that the last survey measurements before the disaster were obtained in 2012, the amount of sediment movement described above may or may not be attributable to the torrential rains. But it may serve as reference data for understanding the tendency of sediment runoff because no significant flood had occurred during the period between 2012 and when the torrential rains came.

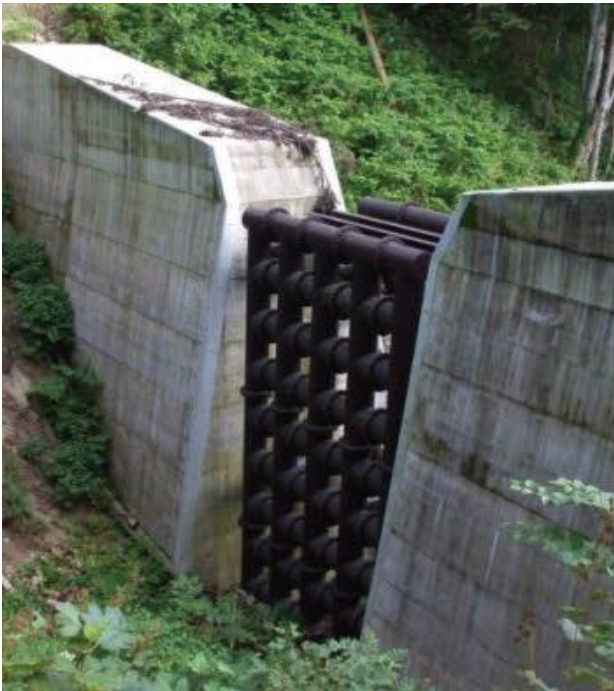
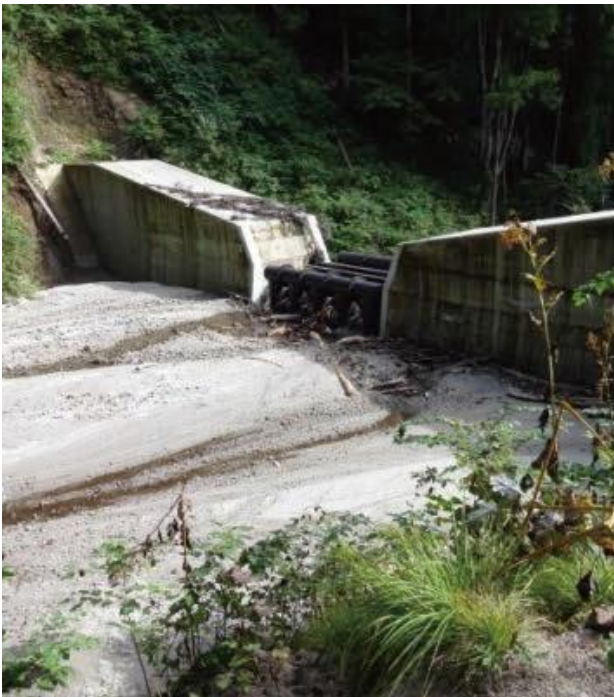
**Fig. 11** Effect of an erosion control facility (Tamoza Erosion Control Dam 1)

(a) Before catching the debris flow (August 18, 2015)

(b) After catching the debris flow (September 26, 2015)

Debris flows also occurred in Tamoza. Three erosion control dams are in operation (one impermeable dam under the control of Tochigi Prefecture and two steel-permeable dams under the control of the Ministry of Land, Infrastructure, Transport and Tourism). These dams caught and controlled sediment and driftwood and prevented the damage from extending to the village located below. The sediment caught by the steel-permeable erosion control dams was relatively small in size, but was blocked by things such as driftwood, rootstock and small particle gravel (**Fig. 11**).

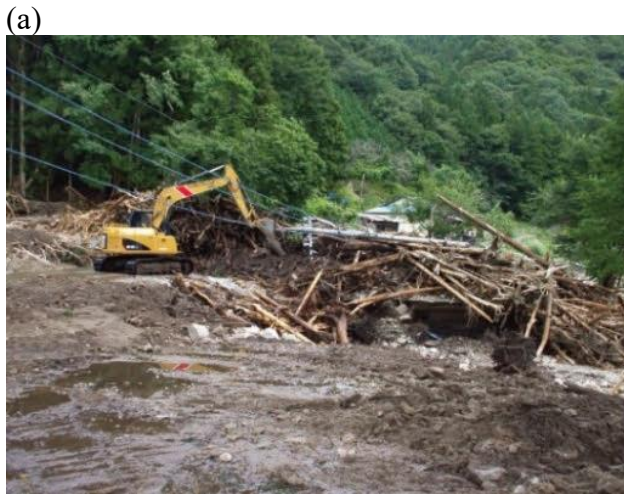
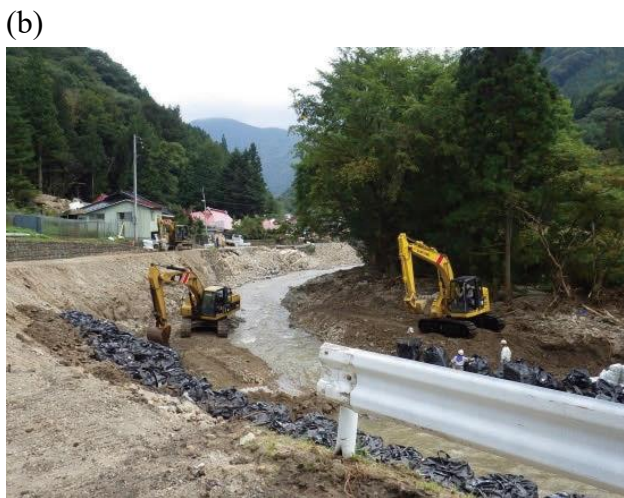
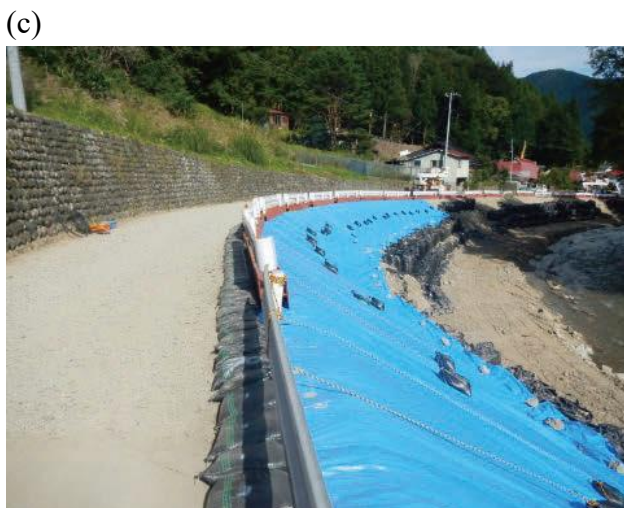
**Fig. 14** Removing obstacles from the road  
 (a) Removing sediment and driftwood  
 (b) Damaged areas are temporarily repaired with large sandbags  
 (c) Road temporarily restored

As the construction of an erosion control dam was underway in the Udonsawa stream of Serizawa District, efforts to remove debris from the municipal road and to temporarily restore the area that had been washed by the flooding started on September 11, with the purpose of solving the isolation problem and securing evacuation routes. The road was opened before September 20 (Fig. 14).

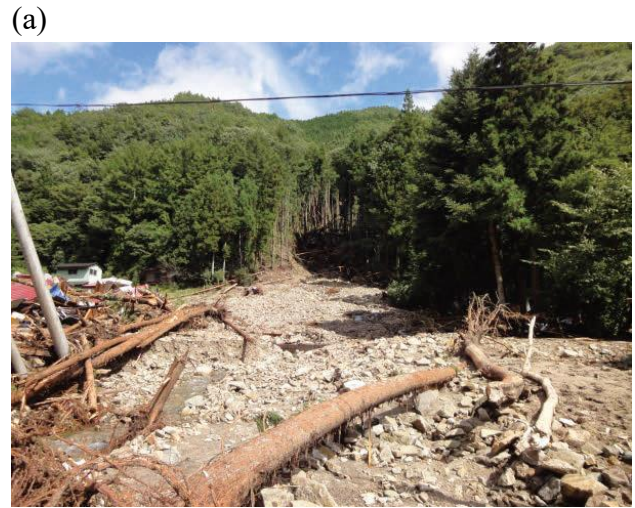
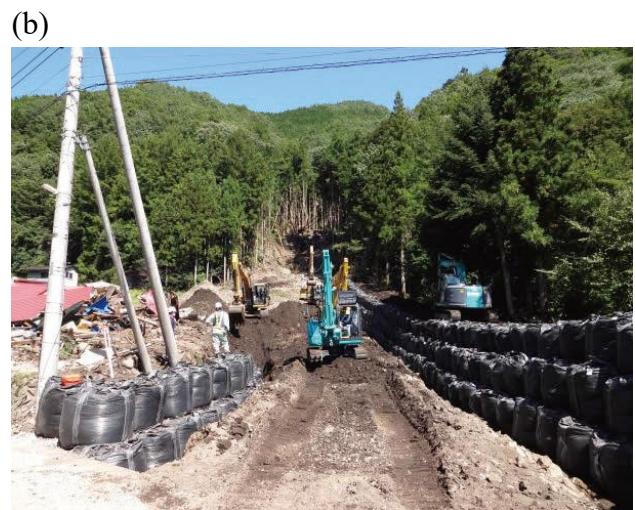
**Fig. 15** Emergency construction  
 (a) Right after the disaster  
 (b) A temporary diversion channel is constructed with large sandbags

Unstable sediment continued to accumulate and the collapses kept expanding in the affected mountain streams. This led to the concern that another disaster would result from even a regular amount of rainfall unless construction of the anti-disaster facilities was completed. For the purpose of ensuring a minimum level of safety required in the inhabited houses around the mountain streams and the temporarily-restored municipal road, four constructors were urgently mobilized in accordance with the anti-disaster agreement and the construction of a temporary diversion channel using large sandbags commenced on September 14. The construction was largely completed by September 24 (Fig. 15).
