TWO LARGE LANDSLIDE DAMS AND OUTBURST DISASTERS - IN THE SHINANO RIVER, CENTRAL JAPAN

Kimio Inoue¹, Toshio Mori² and Takahisa Mizuyama³

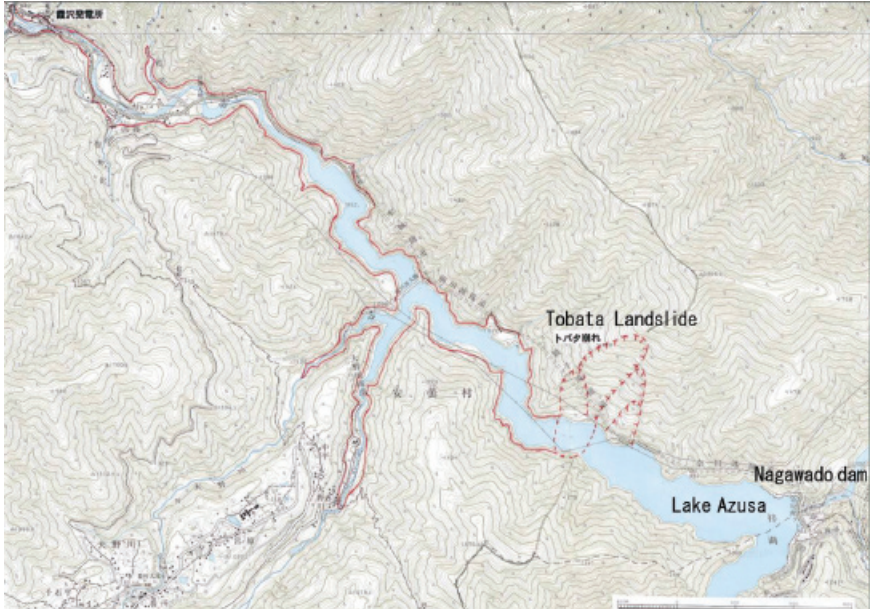
Fig2: Nagawado Dam and Tobata Landslide upstream in the Azusa River

In the Azusa River, three dams – the Nagawado, Midono, and Inekoki Dams – were completed in 1969 by a power generation company and have since been producing hydropower. The Nagawado Dam is an arch dam, 155 meters high, and Lake Azusa with a total storage capacity of 123 millions cubic meters is the dam lake. Figure 2 shows the location of the Nagawado Dam and Tobata Landslide in the upstream section of the Azusa River. This area belongs to the Mino Terrane of the Jurassic Period. The geology in this area consists of an alternation of chert and sandstone/mudstone, and has a strike roughly in the northeast-southwest direction (Otsuka & Nemoto, 2003). Also, a few faults lie in the same direction, together with fractured zones with a width ranging from several tens of centimeters to several meters.

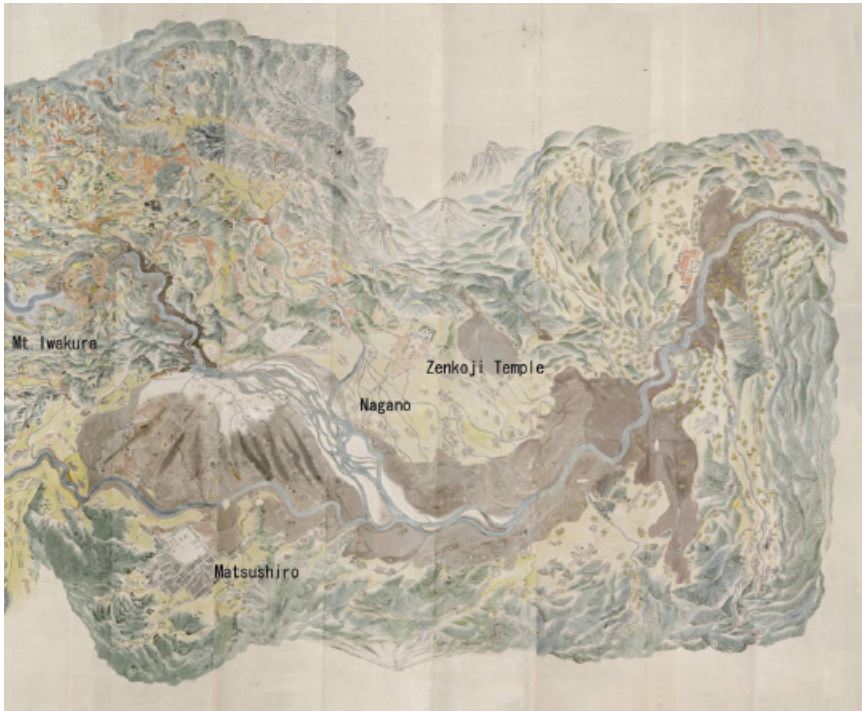
Fig5: Large Earthquake Disaster Map three months after the earthquake (Sanada Museum in Nagano City)

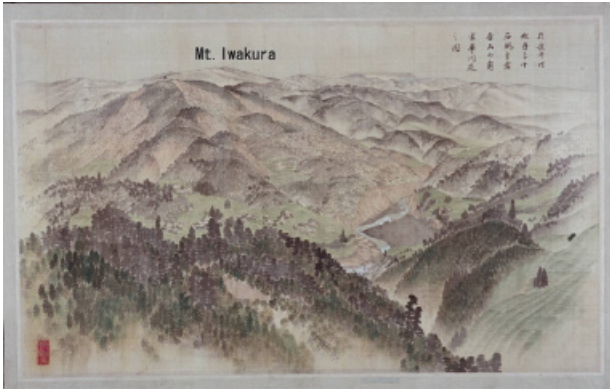
Fig6: Mt. Iwakura landslide dam sketched by Sekkei Aoki two years after the earthquake (Sanada Museum in Nagano City)

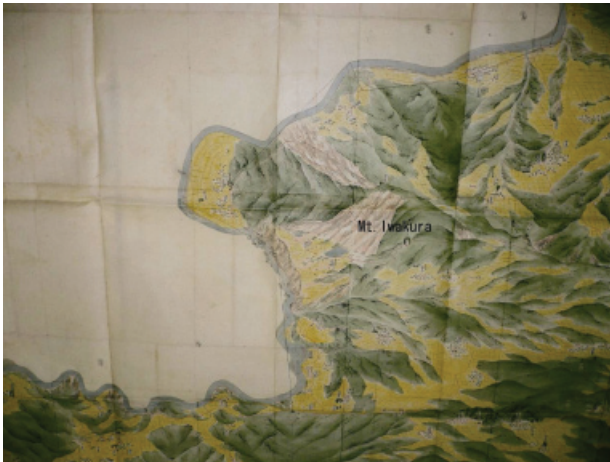
Fig7: Mt. Iwakura landslide dam mapped by the Matsushiro Clan five years after the earthquake (Kyoto University Museum in Kyoto City)
