## REMEDIAL WORKS AGAINST DEBRIS FLOWS AFTER THE 2000 FLOODS IN VALLE D'AOSTA

### ABSTRACT

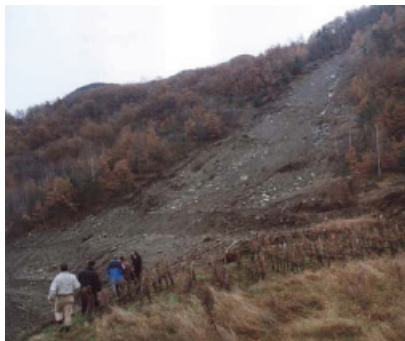
**Fig. 1 :** Oct. 2000 – Miseregne – view of main landslide from downhill side up

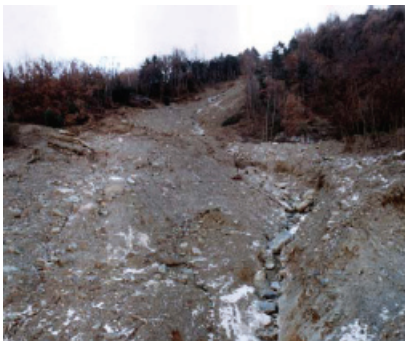
**Fig. 2 :** Oct. 2000 – Miseregne - View of main landslide from the uphill side down

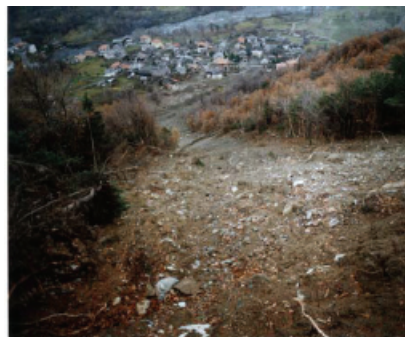
**Fig. 3 :** Oct. 2000 – Miseregne - View of main landslide from the uphill side down

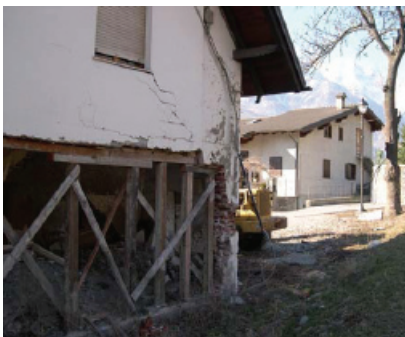
**Fig. 4 :** Oct. 2000 – Nus, house hit by the debris

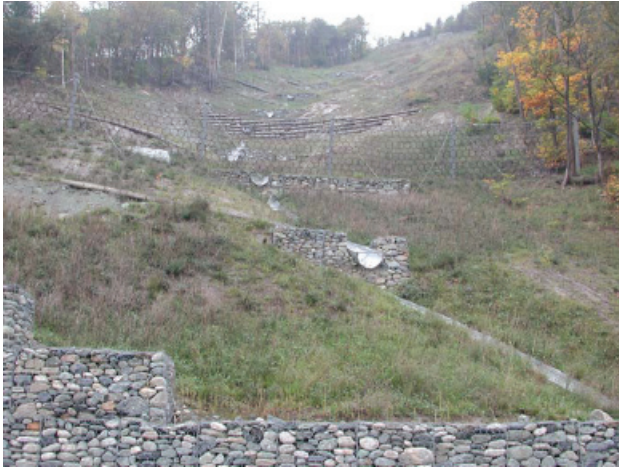
On the top hill side with the gradients steeper than 20%, a first line of protection was made by flexible catch fences to prevent the large rocks from falling down from the top of the hillside were used (Fig.6). These light structures were placed as close as possible to areas where large boulders may dislodge from the slope. In such manner it was anticipated that the maximum energy they will have to withstand will be moderate, since chances that boulders may travel a long distance before their impact against the fence would be low. Additionally, during the flood of October 2000 it was observed that large boulders, detached from the upper sections and rolling down the slope, had magnified the devastating effect of the debris carried by the flow. By preventing large boulders to roll down the slope with the fines, should an event of such magnitude occur in the future the amount and the impact of the debris reaching the bottom of the valley would be drastically reduced. Furthermore, the possibility to separate the large debris on the uphill section will allow an easier maintenance of the structures in a future event. The presence of an existing haul road, once reopened to the traffic, allowed to access the upper section of the damaged slopes and to install the flexible barriers with relatively small efforts.

**Fig. 6 :** Detail view of a flexible catch fence

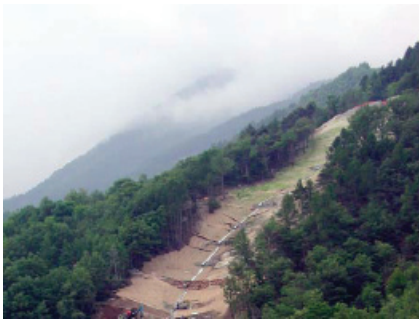
Downhill from the first barrier line of catch fences, biodegradable natural fiber mats and geomats were used to prevent surface erosion, and favor fast vegetation regrowth in the damaged areas were also used, followed by a hydro seeding treatment (Figs. 7, 8).

**Fig. 7:** Upper reach of the conoid, Biodegradable mats and hydro seeding

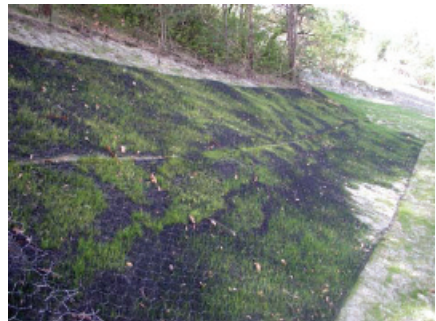
**Fig. 8:** Upper reach of the conoid, Turf reinforcement mats and hydro seeding

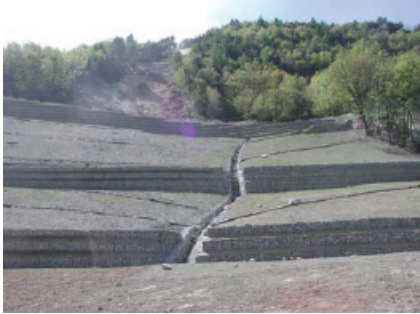
To reestablish adequate drainage and geotechnical stability to the surface on the mid reaches, a series of gabion retaining structures was laid perpendicularly to the main gradient line. In order to harmonize these structures with the surrounding environment, vegetative pockets using jute netting followed by a hydro seeding treatment were also applied (Figs. 9, 10).

Fig. 9: overview of gabion drainage works

Gabions were chosen by the landscape engineers because of their ability to combine three main features in one system: 1) the strength to resist to the external forces due to the combined effect of the rock confined within the steel basket, 2) the high draining capacity due to their porous structure which prevents hydrostatic pressures from building up against the structure behind the wall, and 3) the ability to blend with the natural environment.

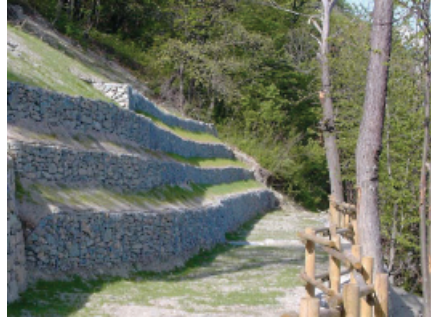
Fig. 10: view of the vegetative pockets

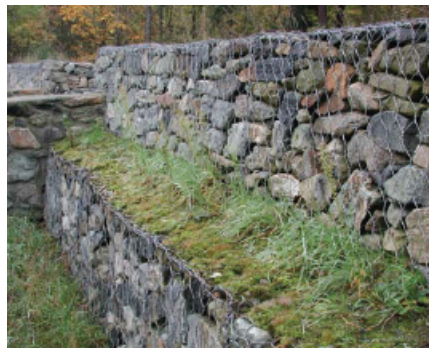
The presence of voids inside a component made of solid natural rock, makes these structures suitable for the incorporation of vegetative systems. During installation, on the outer side of the gabion structure a series of vegetative pockets were installed. This technique consists in unrolling a strip of jute netting in a channel like shape longitudinally to the gabion wall (Figs. 11, 12).

Fig. 12: view of vegetative pocket

In such way the jute will work as a confinement for the vegetative soil which will be then filled in. Once soil filling is complete and leveled to the top of the gabion course, the jute on the upper lateral sides is folded and the vegetative pockets are closed.

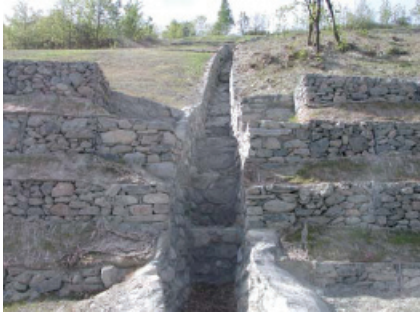
A drainage trapezoidal channel made with masonry cemented rock was laid in the center sections to convey the rainfall run off along the maximum gradient line (Fig.13). Alternatively for some areas, in order to control the flow conveyance, lateral timber piles (obtained using the logs from trees dragged by the flow) and drainage works were also laid in a fishbone pattern perpendicular to the flow direction (Fig.14).

**Fig. 13:** view of the drainage channel

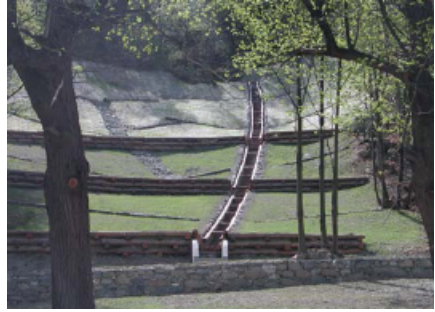
**Fig. 14:** view of alternative drainage works

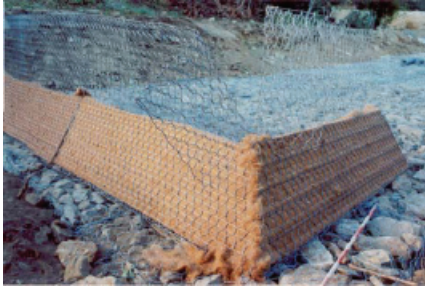
The embankment foundation is made by a 500 mm gabion apron (Fig.16), which will provide further draining capacity to the whole structure. A small channel on the uphill side lined with an antierosive geomat was included, with the purpose to catch all the surface runoff and drain it away.

**Fig. 16:** Rovarey, deflecting wall at the beginning of construction

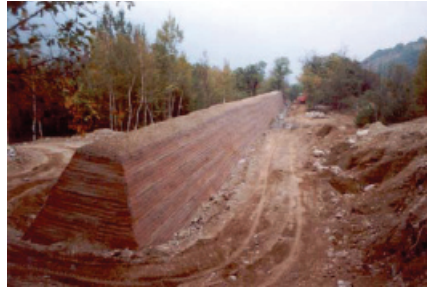
**Fig. 17:** Rovarey, deflecting wall at end of construction

Advantages of building reinforced soil embankments were twofold: a) compared to conventional earth filled embankments they require a limited base width (sloping the sides at 65 degrees) hence a lesser amount of fill (Figs.17, 18), b) due to their ability to incorporate vegetative soil they allow a naturally green face to develop along their slopes which will soon turn the structure to blend with the natural surrounding (Fig.19). Furthermore, the vegetation growth will provide additional strength to the embankment through the rooting and the overall vegetation establishment. Appropriate drainage measures were also used to ensure the stability of the embankment's foundation.

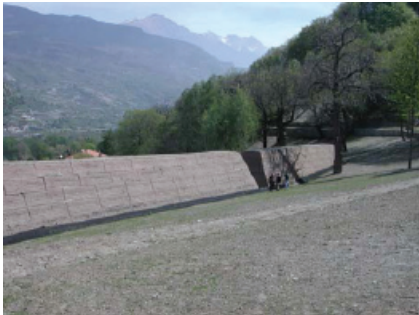
**Fig. 18:** Miseregne, openings to let the flow through without pressure build-up

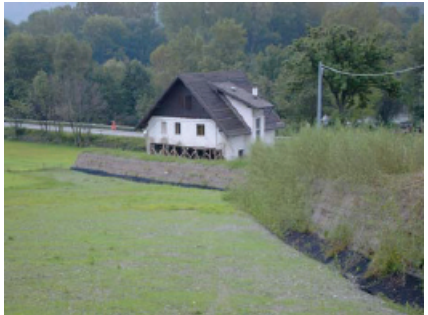
**Fig. 19:** Nus, deflecting wall at downstream end

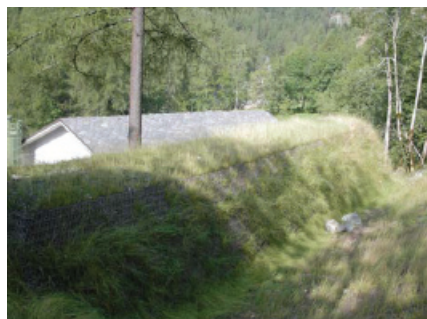
Since the year 2001, the training works of Fenis, Miseregne, Rovarey and Nus in the Aosta Valley were subject to constant monitoring from the Regional Authority (Figs. 20, 21).

**Fig. 21:** 2002, Rovarey, view of a vegetated barrier

Results have been satisfactory and encouraging. They have shown that the principle of diversifying the type of structures from the top hill down is fundamental when dealing with vast areas subject to unpredictable and hazardous debris flows. Another positive reason is that all structures used were particularly suitable for incorporation of soil bioengineering techniques. This aspect was fundamental to provide a sustainable ecologically balanced recovery. In this regard all the recovery works demonstrated the ability to blend with the surrounding environment, soon reestablishing the original and natural wildlife of the valley. Particularly successful in this regard were the vegetative embankment barriers where vegetation took over right after the first season.
