Maintenance and Utilization of a Sabo Facility Designated as an Important Cultural Property - The Shiraiwa Sabo Dam -

Takeshi OSAKA^{1*} and Hisashi WATANABE²

This report introduces the effort of maintenance and utilization of Tateyama Mountain Area Sabo office against maintenance and management issues surrounding modern sabo works. The maintenance of the Shiraiwa Sabo Dam is described, particularly in the context of maintaining its disaster prevention function and conserving its value as a cultural property. It is hoped that this report on the Shiraiwa Sabo Dam will help guide the maintenance and management of other Sabo facilities designated as Important Cultural Properties.

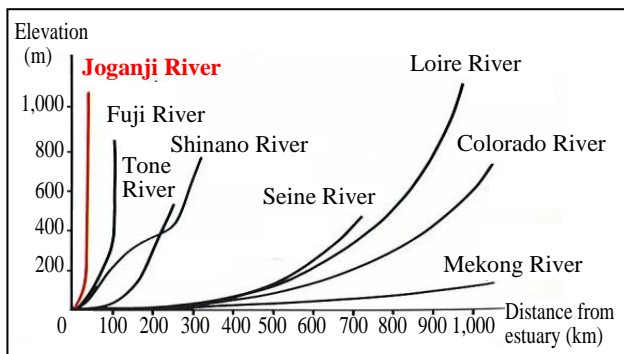
Fig. 1 Slope of the Joganji riverbed relative to other of other rivers

The Joganji River is one of steepest rivers in Japan, flowing 56 km from the 3,000 m-high mountainous area in the east of Toyama Prefecture to Toyama bay. The average slope of the riverbed is about 1/30 (**Fig. 1**). In the upstream area of the Joganji River lies the Tateyama Caldera, which extends 6.5 km east-west and 4.5 km north-south, and has a fragile geology composed of Tateyama Volcano ejecta. In addition, the Atotsugawa fault, which is prone to collapse, lies in the vicinity.

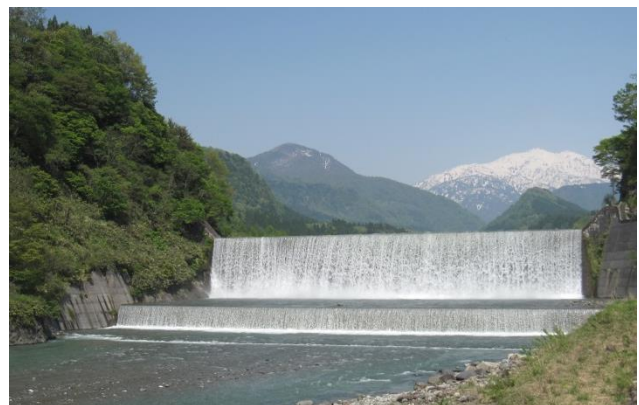
Fig. 5 Hongu Sabo dam (present day)

The dam height is 22.0 m and the crest length is 107.4 m; a total of 23,500 m³ of concrete was used in the construction of the dam body. There are five counter dams, and the sediment trap capacity is the largest in Japan, at 5 million m³.

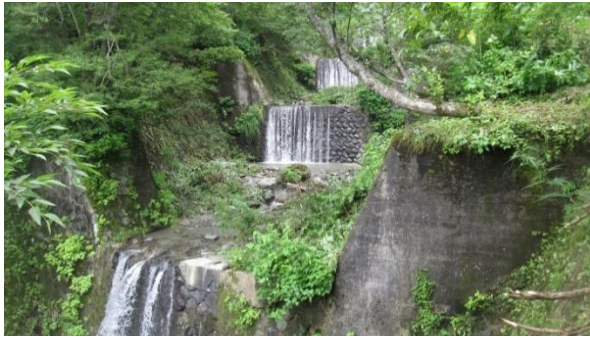
Fig. 6 Dorodani Sabo Dams (under construction)

The Dorodani Sabo Dams were constructed just under the Tonbi landslide area to prevent devastation of the Dorodani valley (Fig. 6). The Dorodani Sabo Dams are a series of stepped dams consisting of 20 check dams, 3 groundsills, and hillside works.

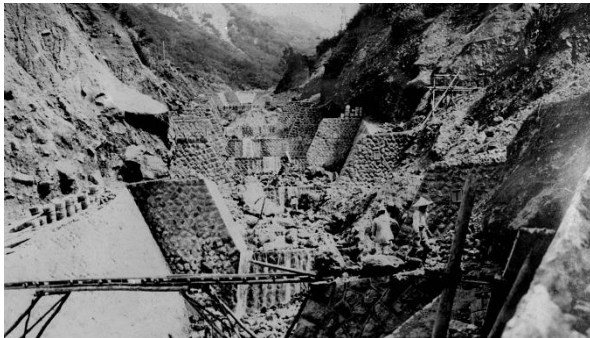
Fig. 7 Dorodani Sabo Dams (present day)

Initially, Toyama Prefecture constructed sabo facilities in Dorodani, but these were damaged during the heavy rains of 1929. The Ministry of Japan started re-construction of the Dorodani Sabo Dams in 1930 (Fig. 7).

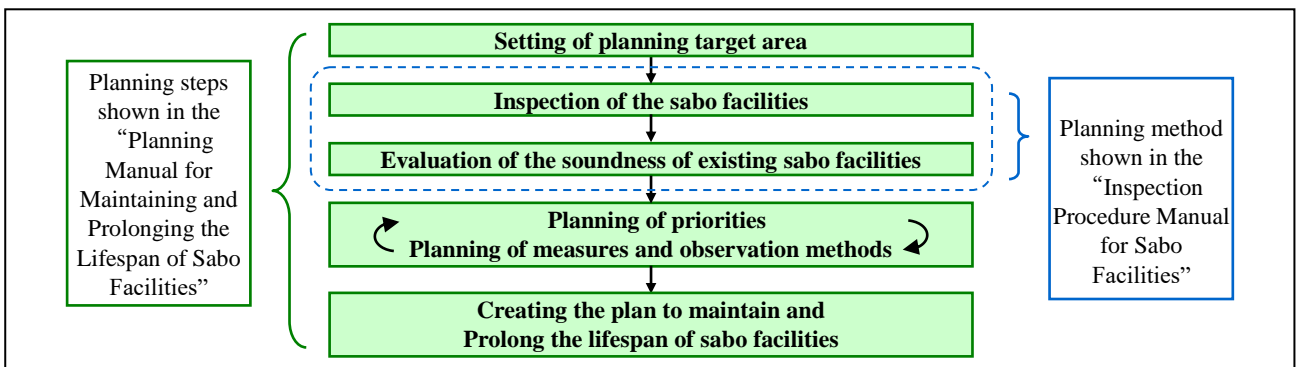
Fig. 8 Contents of the “Planning Manual for Maintaining and Prolonging the Lifespan of Sabo Facilities” and the “Inspection Procedure Manual for Sabo Facilities”

In addition, the Erosion and Sediment Control Department of the MLIT issued manuals to sabo offices, which were designed to help facility managers investigate the soundness of existing facilities and plan lifespan-prolonging maintenance activities (Fig. 8).

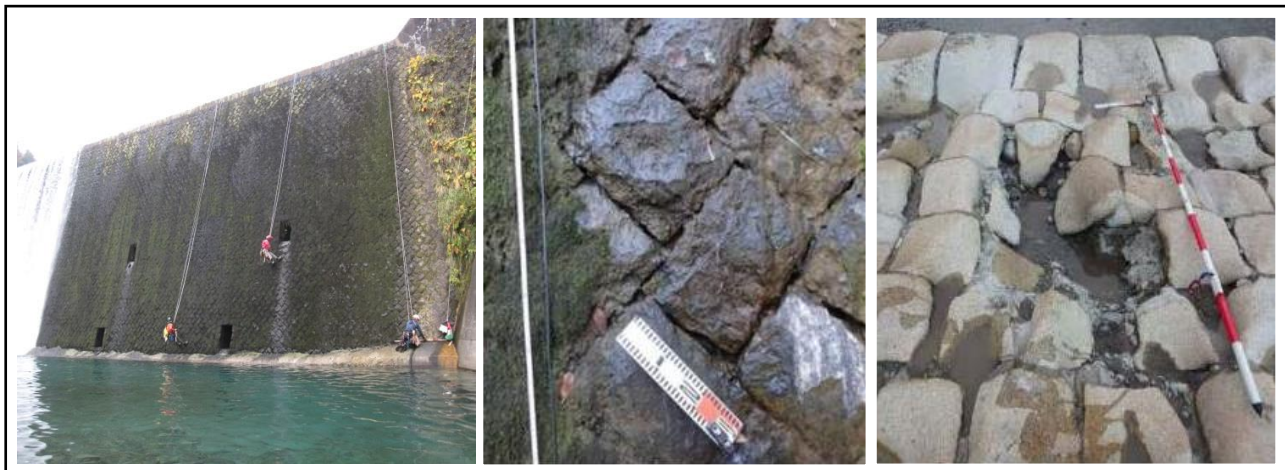
Fig. 10 Example images of detailed visual inspections of sabo facilities

Important Cultural Properties will be carefully inspected and scrutinized via detailed inspection, boring surveys, elastic wave surveys, etc., to maintain their status as Important Cultural Properties (Table 2, Fig. 10).

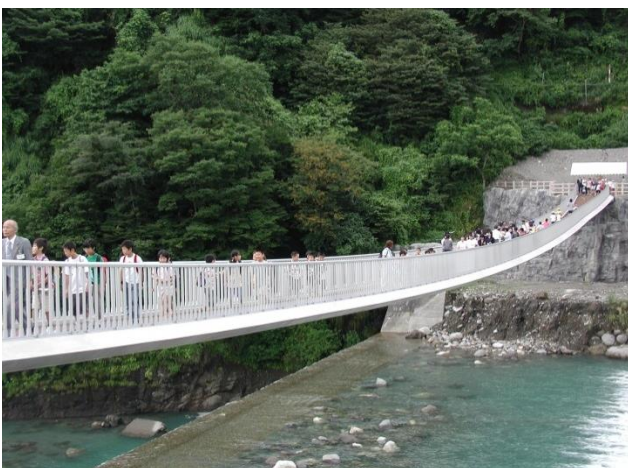
Fig. 16 Hongu Sabo dam maintenance bridge
