Property of Sediment Movement in Azusa River (Kamikochi)

Akihiko IKEDA^{1*}, Yuki IGARASHI¹, Osamu FUSHIKI¹, Hiroki UEMORI¹,
Shoji IGARASHI², Masahide HASEGAWA³ and Hidenori SAKO⁴

¹ Sabo and Landslide Technical Center, Japan (4-8-21 Kudan-minami, Chiyoda-ku, Tokyo 1020074, Japan)

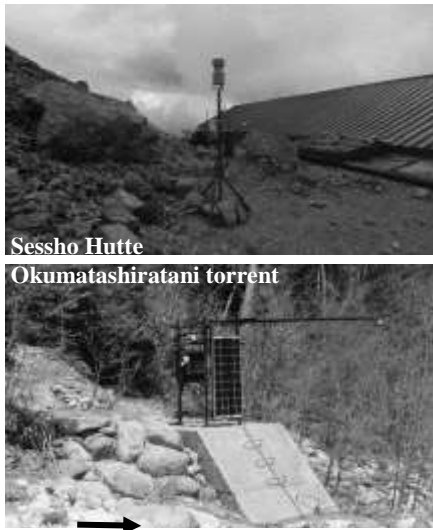
Fig.3 Installation of rainfall and water level gauges

Table 1 shows the outline of flood events that occurred in 2015 to 2017, after the installation of the rainfall gauges at the ridge line and water level gauges in the tributary (**Figure 3**). The flood is defined that more than 20mm of hourly rainfall, 80mm of continuous rainfall, 50m³/s of discharge at Yokoo-ohashi bridge and 100m³/s of discharge at Kamikochi water level gauging station. In Kamikochi, the movement of heavy rain area during the flood tends to move west to east or southwest to northeast in the past floods influence of the movement of the seasonal rain front or typhoon. We focused on the flood occurred on July 1st, 2017 (hereinafter called 2017 flood) that the largest peak discharge in the past and significant sediment movement has been confirmed.

The rainfall and discharge, which dominates the sediment movement, are observed by installing rainfall gauges and water level gauges since 1981. Rainfall gauges are installed at 6 locations in the mountain huts and ridge lines (elevation around 2,000m; Sessho Hutte, Karasawa Hutte, Chogadake Hutte, Nishiho, Tokugotoge Mountain Hut and Mt.Kasumizawadake), and 4 locations along the main stream in the grand valley (elevation around 1,500m; Yokoo, Tokusawa, Myojin-ike pond and Kamikochi). Rainfall gauges in the ridge line are used for observation only when the mountain huts are open (for 5 months of the non-snow season). Water level gauges are installed at 4 locations in tributaries where sediment discharge flow into the main stream is significant (Okumatashiratani torrent, Tokusawa torrent, Shirasawa torrent and Hachiemonzawa torrent), and 5 locations in the main stream from upstream to downstream (Yokoo-ohashi bridge, Yokoo narrow section, Myojin-bashi bridge, Kamikochi and Kamikochi water level gauging station). At Okumatashiratani torrent, Tokusawa torrent, Shirasawa torrent, Hachiemonzawa torrent, Yokoo-ohashi bridge and Yokoo narrow section, the video camera has also installed for observing the flow condition. The discharge of main stream is calculated according to the relationship between the water level and discharge (H-Q formula) and the discharge of tributaries according to Manning's formula.

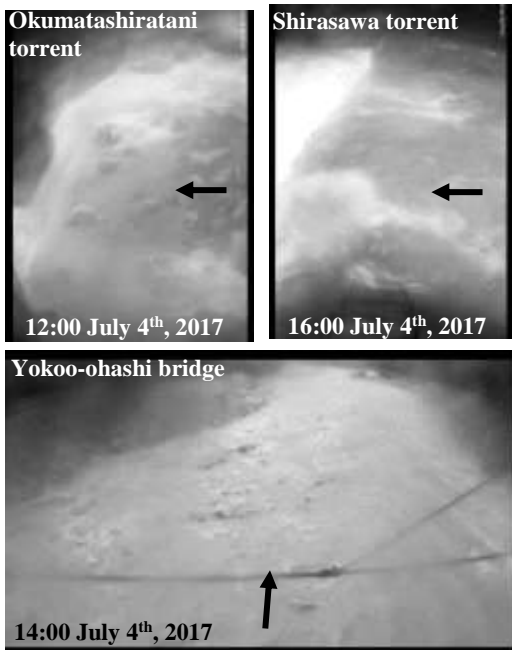
Fig.5 Time changes of discharge and flow condition during the flood on July 1st to 4th in 2017

Figure 5 shows the time changes of discharge at main stream of Azusa River from upstream to downstream and Shirasawa torrent, with the images of flow condition in Okumatashiratani torrent, Shirasawa torrent and Yokoo-ohashi bridge. It was not clear by the waveform of rainfall, but two clear peaks of discharge were confirmed on July 1st (first peak) and July 4th (second peak). As for the first peak, the discharge and turbidity started to increase simultaneously and rapidly 3 hours later after beginning of rainfall, that the waveform shape is similar to rainfall with good responsiveness at

Shirasawa torrent. On the other hand, the discharge started to increase gradually 2 hours later after beginning of rainfall at Yokoo-ohashi bridge and Yokoo narrow section, while 4 hours later at Kamikochi water level gauging station. After that the discharge started to increase rapidly with the rainfall, while the waveform shape differs after the peak from the rainfall that influence of the subsurface runoff. The peak discharge of Yokoo-ohashi bridge, Yokoo narrow section and Kamikochi water level gauging station that locates upstream to downstream of the main stream is 96m³/s, 92m³/s and 202m³/s, and the specific discharge is 3.13m³/s/km², 1.94m³/s/km² and 2.49m³/s/km² (**Table 1**). Kamikochi water level gauging station has a discharge almost twice that of Yokoo-ohashi bridge, and that of the peak appearance time delayed for 2 hours. In spite of Yokoo narrow section locates downstream and watershed area is larger than Yokoo-ohashi bridge, the peak discharge and specific discharge is smaller than Yokoo-ohashi bridge.

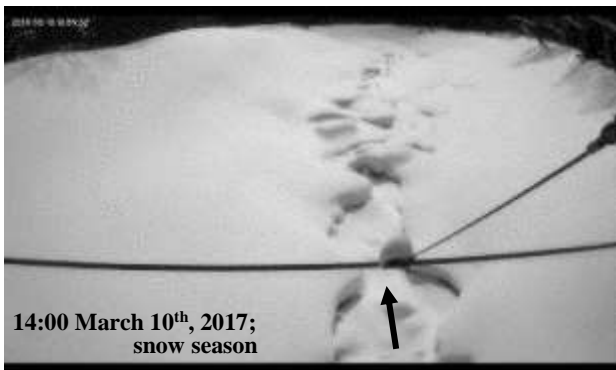
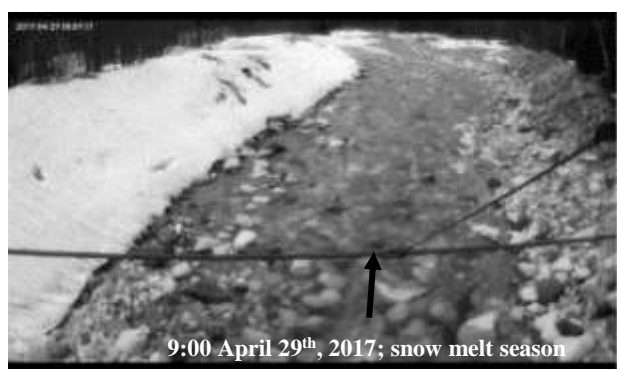
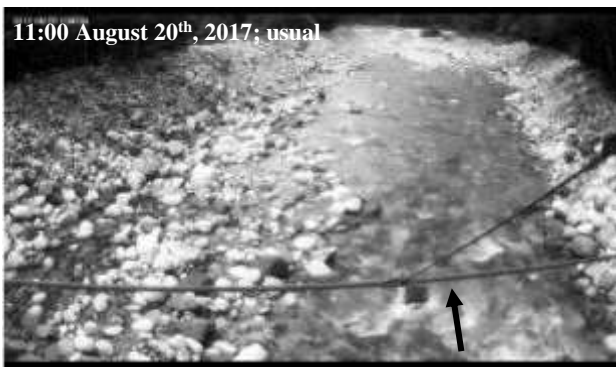
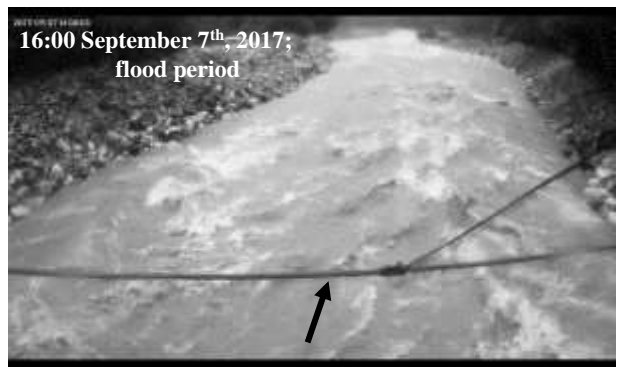
Fig.6 Time changes of discharge and flow condition during October, 2016 to November, 2017 at Yokoo-ohashi bridge

In Kamikochi it begins to snow from around December and covered with snow until May, while that start to melt around April, so that it is covered by snow through the half of year. **Figure 6** shows the time changes of discharge and flow condition during October, 2016 to November, 2017 at Yokoo-ohashi bridge. The time changes of discharge roughly divided into 4 periods according to the season, such as usual, flood period, snow season (December to April) and snow melt season (April to June). The average discharge at Yokoo-ohashi bridge is approximately 2-5m³/s as usual, less than 3m³/s in the snow season, and 2-3m³/s during the early snow melt season with 10m³/s in late period. During the snow melt season, as the temperature changes, the discharge is changing in the day. Such a trend is confirmed at Kamikochi water level gauging station, Tokusawa torrent and Shirasawa torrent. At Kamikochi water level gauging station downstream end of the main stream, the average discharge is approximately 5-10m³/s as usual, 3-4m³/s in the snow season, and approximately 5m³/s during the early snow melt season with 10-25m³/s in late period.
