Analysis and Reconstructed Modeling of the Debris Flow Events on the 29th of August and the 4th of September 2016 of Afritz (Carinthia, Austria)

Claudia SAUERMOSER^{1*}, Markus MOSER² and Susanne MEHLHORN²

¹ Regional Headquarters Carinthia Northeast, Austrian Service for Torrent and Avalanche Control, Austria

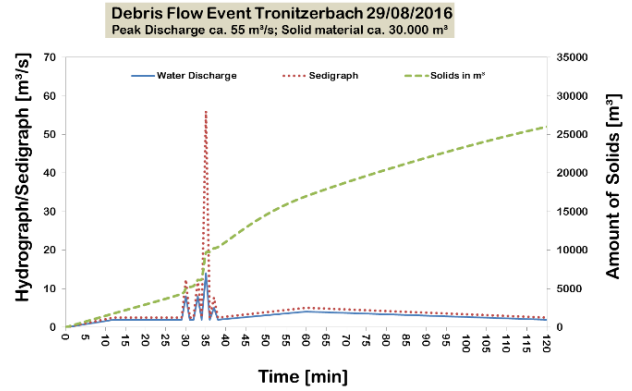
Fig. 2 Hydrograph as input parameter for FLO-2D and RAMMS with a peak discharge of 55 m³/s and a max. bed load of 30,000 m³

For both models a grid size of 1.5x1.5 m was used. The Manning coefficients for FLO-2D were determined on the basis of the field survey. As a basis for the estimation of the sedigraph (**Fig. 2**), the documented outcomes from the event analysis (reconstructed impact boundaries based on the silent witness, debris flow peak discharge, analyzed event time for event-duration, debris flow mass) were used.

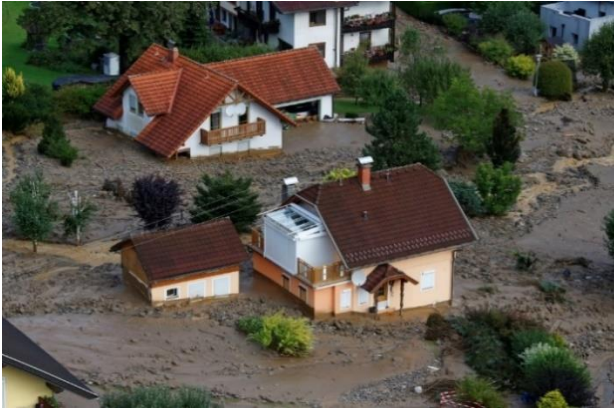
Fig. 6 Damaged buildings after the 2nd debris flow on 4th of September 2016

In total, 45 buildings and infrastructure were damaged along the Tronitzer Torrent (**Fig. 6**). However no people were hurt or killed by the debris flows.

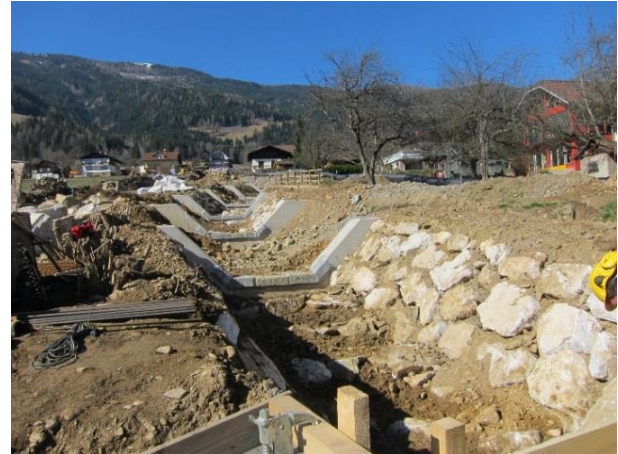
Fig. 10 Bedded rockfill and concrete sills along the lower reach

- a water retention basin in the upper catchment to reduce the impact of the surface runoff
- a chain of check dams to stabilize the bed and the banks in the middle reach
- a debris flow breaker to transform the process, filtering of coarser fraction of the debris and to retain 6,000 m³ of solids
- a bedload sorting dam with a length of 250 m and a height up to 14 m to retain 37000 m³
- a bedded rockfill and concrete sills along the lower reach in the settlement area (**Fig. 10**).

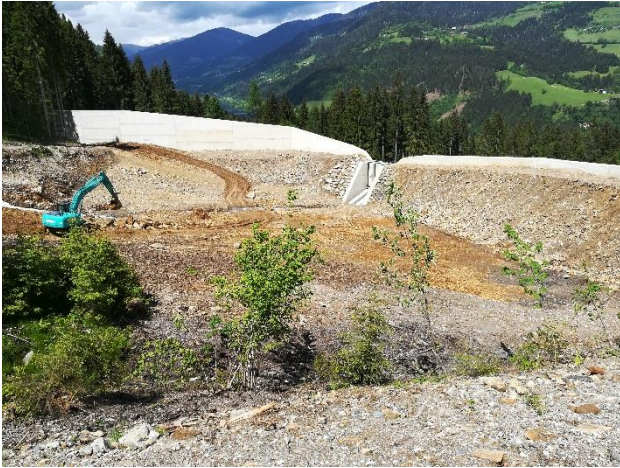
Fig. 11 Bedload sorting dam with a retention capacity of 37,000 m³ with a length of 250 m and a height up to 14 m

The control measures in the lower reach of the Tronitzer Torrent were finished in 2017. After finishing the sediment control dam in 2018 (**Fig. 11**) the water retention basin in the upper catchment and the debris flow barrier will be built.
