ANALYSIS OF TORRENT PROTECTIVE STRUCTURES AS A BASIC ELEMENT OF THE HAZARD MAPPING PROCESS

DETERMINING THE AS-IS-STATE OF 100 YEARS OLD CHECK DAMS MADE OF NATURAL STONE MASONRY

Bernd Kister¹, Markus Zimmermann², Gabi Hunziker³, Bruno Zimmerli⁴ and Walter Fellmann⁵

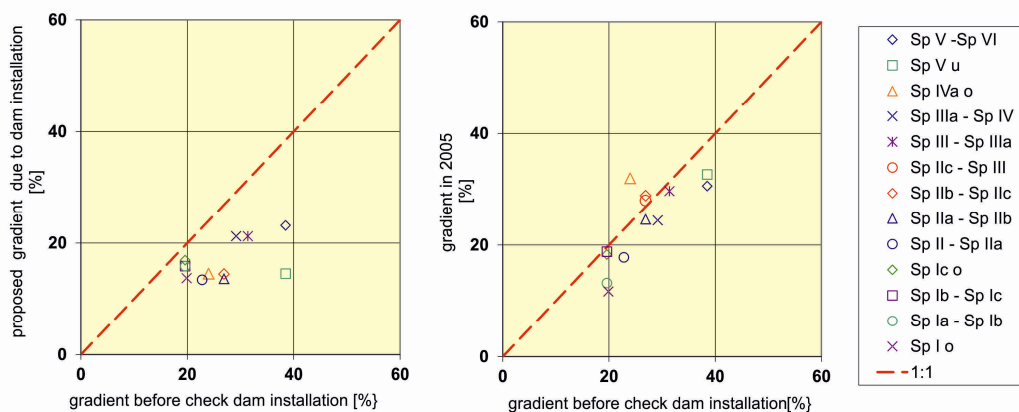
A comparison of the gradient along the Lammbach gorge at different times shows also significant changes. Fig. 4 shows on the left that the gradient was significantly reduced as a result of the construction of the check dams in the years 1896 – 1913. This was one of the aims which had been connected with the construction of the check dams. But today due to sedimentation of debris along the Lammbach gorge the gradient is in many cases similar to that one before the construction of the check dams. In the case of the upstream area of check dam IVa the gradient has been even increased in comparison to the situation before dam construction (Fig. 4, right).

Fig. 4 Left: Comparison of the gradient before the installation of the check dams and the gradient expected due to dam installation (cp. Fig. 3), right: Comparison of the gradient before the installation of the check dams and the gradient measured by aerial survey in 2005 (legend: Sp = check dam, o = upstream, u = downstream)

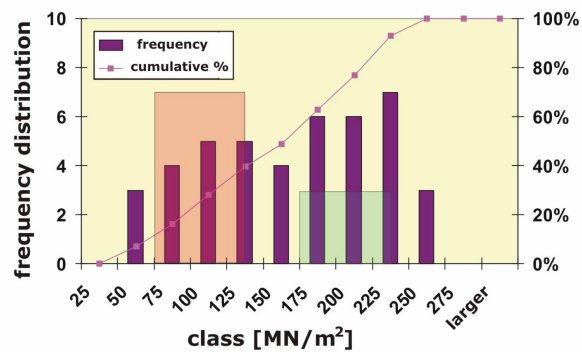
For the determination of the uniaxial compressive strength of the rock with the Schmidt-hammer the formulas of Deere & Miller (1966) have been used. To confirm the results produced with the Schmidt-hammer some compressive tests on drill cores have also been done. Comparing these test results, it can be mentioned, that there is a difference in the compressive strength of the rock blocs used for the check dams. So the compressive strength of the rock blocs used for barriers IV and IVa was found to be less than the compressive strength of the rock blocs used for the barriers Ia, Ib and Ic. Fig. 9 shows the results of Schmidt-hammer tests in comparison to results of uniaxial compression tests on rock material. The compressive strength $f_{d,M}$ of the natural stone masonry was evaluated to approximately 6 MN/m^2 by using the formula of Berndt (1996).

Fig. 9 Uniaxial compressive strength of the siliceous limestone, dark bars: frequency distribution of Schmidt-hammer results; left-hand side: band of test results of uniaxial compression tests, cores derived from check dams IV, IVa and rock blocs of the area between check dam IV and check dam IVa; right-hand side: band of test results of uniaxial compression tests, cores derived from rock blocs of the area check dam I to check dam Ia

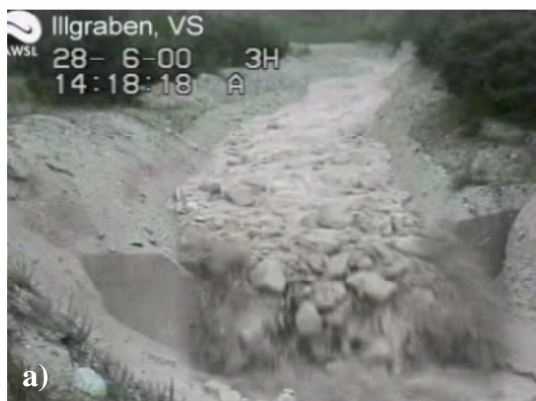
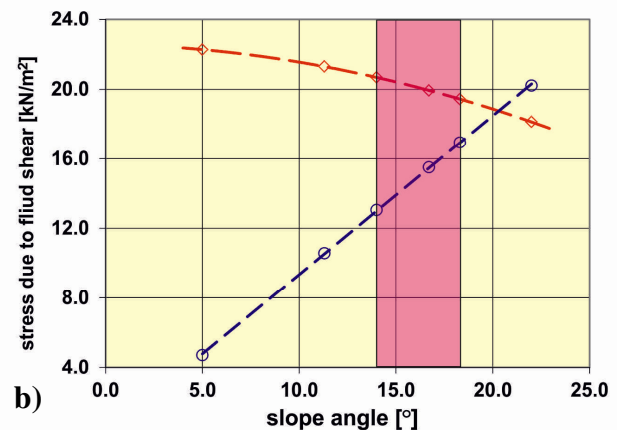
Fig. 11 a) overtopping of a check dam by a debris flow (WSL, 2000), b) correlation of stress due to fluid shear and slope angle, comparison of 2 models, marked area is decisive for the Lammbach check dams.

For a debris flow with a density $\rho_{\text{Mu}} = 1800 \text{ kg/m}^3$ and a height $h_{\text{Mu}} = 3 \text{ m}$ the correlation of stress due to fluid shear and channel gradient respective slope angle is shown in Fig. 11. The red marked area is the representative interval for the gradient in the Lammbach gorge.

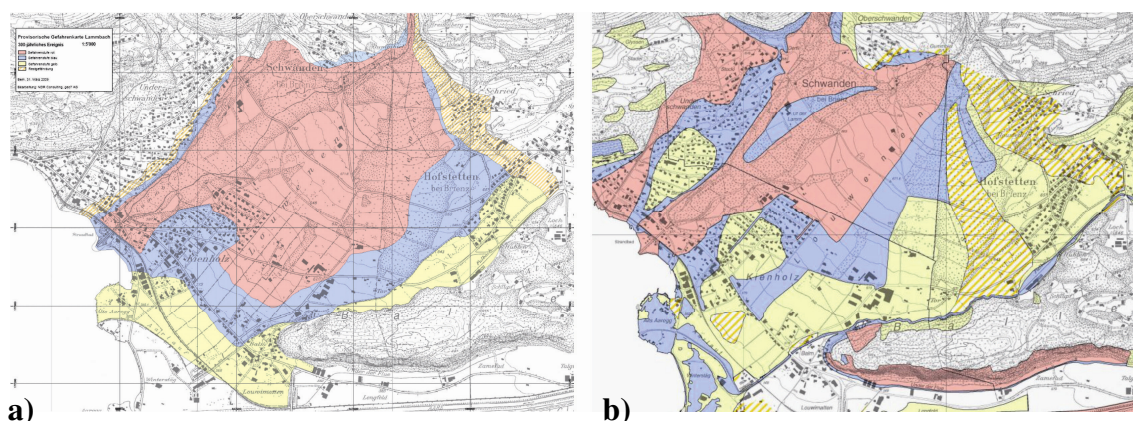
Fig. 14 Hazard maps obtained with different scenarios: a) failure of check dam IVa, debris flow volume at the fan apex will be approx. $790'000 \text{ m}^3$, b) check dam IVa remains stable, a debris flow volume of approx. $95'000 \text{ m}^3$ is overtopping check dam IVa, a volume of $220'000 \text{ m}^3$ debris will reach the fan apex.

In comparison to a scenario taking into account the failure of all dams, the scenario of a 300 year event shows a significant smaller so called “red area” in the hazard map, which is the area where the construction of new buildings is prohibited (Fig. 14). To choose this scenario as the most likely
