# Emergency Responses to Debris Flow Disaster at Serizawa District, Nikko City Triggered by the 2015 Torrential Rains in the Kanto and Tohoku Region

Kenji MIWA<sup>1</sup> and Kenji TAKETOSHI<sup>1</sup>

<sup>1</sup>Member, Nikko Sabo Office, Kanto Regional Development Bureau, Ministry of Land, Infrastructure, Transport and Tourism (2390 Hangakimen, Nikko City, Tochigi 3211414, Japan)

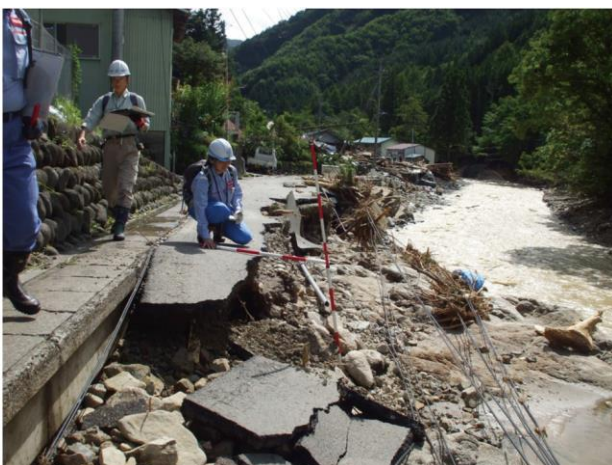
Fig. 12 On-site survey

Four construction consultants were urgently mobilized in accordance with the Staff and Disaster Agreement. In the early morning of September 11, they entered the Serizawa District and started a detailed on-site survey of the mountain streams in an effort to stay updated on the status of sediment runoff and damage (Fig. 12).

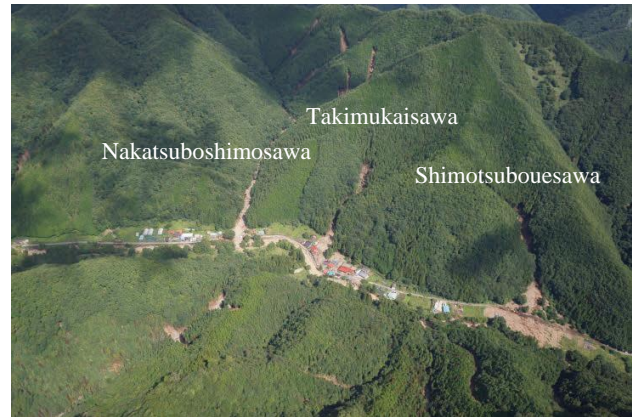
Fig. 13 Aerial view of Serizawa District

From September 11 to 13, Aozora, a disaster-control helicopter from the MLIT Kanto Regional Development Bureau, was used to extensively survey the damage from above the jurisdiction including Serizawa District, focusing on the upstream areas of the mountain streams where ground-based surveys would be difficult to carry out (Fig. 13).

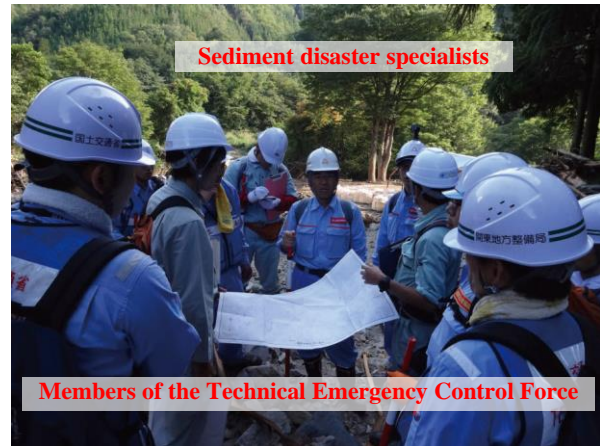
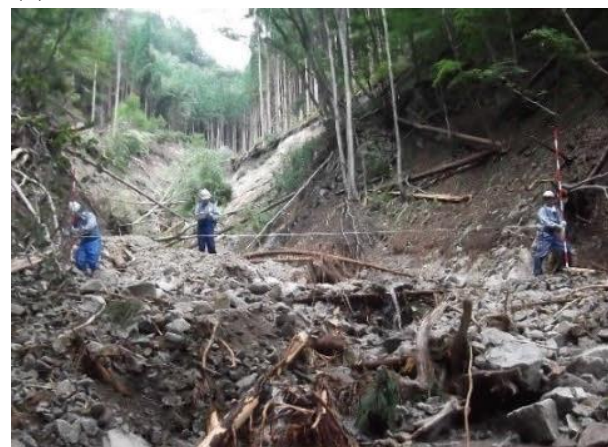
**Fig. 16** Activities of sediment disaster specialists and the Technical Emergency Control Force

(a) Technical guidance at the site

(b) Urgent inspection of a hazardous area

On September 14, twenty staff members from the MLIT Kanto Regional Development Bureau were sent to Serizawa District as the Technical Emergency Control Force (TEC-FORCE), with the aim to urgently perform an inspection of sediment disaster hazards, including the mountain streams that could be affected by debris flow and steep slopes with the potential to collapse (Fig. 16).
