# Actions for the Maintenance and Lifespan prolongation of SABO Facilities

Hisashi Watanabe, Professional engineer<sup>1</sup>; Toshio Mori

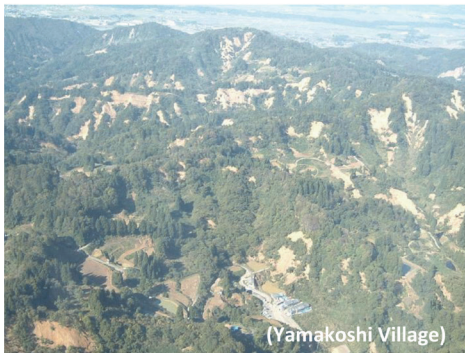
Location	Niigata Prefecture Chuetsu region
Date	October 23, 2004
Scale of earthquake	Magnitude 6.8
Landslide dam was created	45 places
Debris flow	19 places
Landslide	41 places
Criff failure	45 places
Dead	46 people
Injured	4,801 people
House destroyed	2,827 houses
House partially destroyed	12,746 houses
House some damage	101,509 houses

Figure 1: Overview of the damage caused The Niigata Prefecture Chuetsu Earthquake

Recently, typhoons, earthquakes, and volcanic eruptions have increased in scale. In addition, the frequency of localized torrential rain from continuously generated clouds, the so-called “back-building phenomenon”, has increased. This has led to large-scale sediment-related disasters, such as those observed in the Niigata Prefecture Chuetsu Earthquake (2004; Fig. 1)

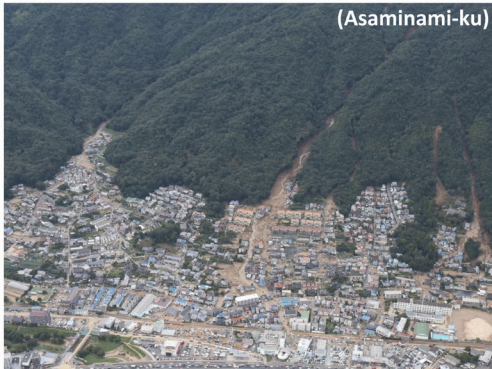
(Asaminami-ku)	Location	Hiroshima Ctiy, Hiroshima Prefecture
		Date	August 20, 2014
		Debris flow	107 places
		Criff failure	59 plases
		Dead	73 people
		Injured	39 poeple
		House destroyed	123 houses
		House partially destroyed	82 houses
		House some damage	150 houses

Figure 3: Overview of sediment-related disaster in Hiroshima, and 60 minutes accumulated rainfall (13:00 August 19–13:00 August 20)

and extensive sediment-related disasters in the Kii Peninsula (2011, Fig. 2) and Hiroshima (2014; Fig. 3). Consequently, appropriate countermeasures are required to ensure regional safety.
